Determination 2018/014

The refusal of a code compliance certificate for alterations to a house at 13 Clifford Street, Gisborne

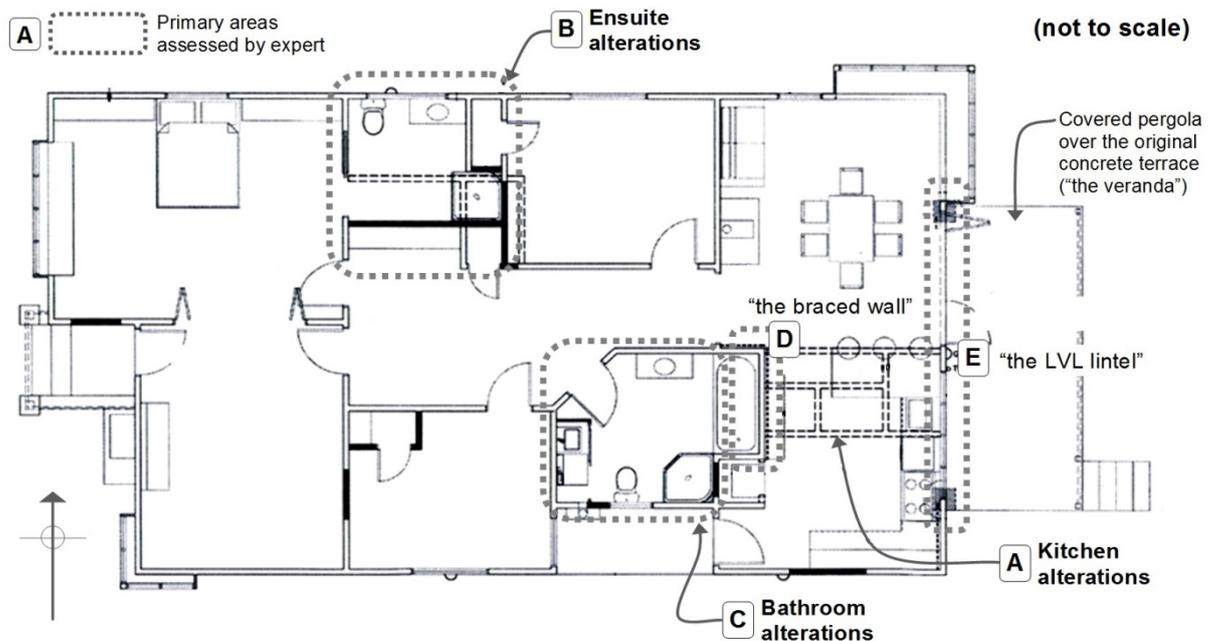
Figure 1: Floor plan of alterations

2.2.1 The alterations have not extended the building envelope of the original house. As shown in Figure 1, alterations were to three primary areas as follows:

- 3.2.5 The engineer's review addressed the absence of the plywood bracing element noted by the expert (see paragraph 4.6.1) but the review made no comment on the remaining matter being the lack of a connection to the bottom of the LVL lintel beam (Area E on Figure 1).

4.3.3 In regard to the braced wall (Area D), the expert noted that:

- the drawings called for the corner walls around the north east sides of the bathtub to be braced on the kitchen/dining side with 12mm plywood sheets

- drilling through lining at the corner of the wall revealed rimu drillings, with no evidence the plywood had been installed

4.3.4 In regard to the LVL lintel (Area E), the expert noted that:

- the old joinery was removed, with a 5.3m lintel installed over the opening for the kitchen window and the dining bi-fold door
- the large original concrete pad at the SE corner is close to, but not directly beneath the south support studs to the lintel opening
- the original foundations support two 90 x 45mm studs under the lintel end in lieu of a 90 x 90mm post fixed to a new concrete pad with stainless steel brackets anchored into the concrete
- removal of a small section of lining beside the north end of the door sill revealed a galvanised angle bracket bolted through double studs and fixed with coach screws through the bottom plate into underlying timber, with no connection extending into the concrete foundation wall.

- plywood sheet bracing has not been installed to the braced wall (Area D)
- galvanised angle brackets to the lintel support studs do not connect to original concrete foundations (Area E).

- the lack of plywood installed to the braced wall (Area D)
- the structural connections of the bottom of lintel support studs (Area E)
- the unsealed junctions at the:
 - jamb facings to the kitchen window (Area E)
 - bathroom water heater junctions with the weatherboards
 - ensuite toilet drain pipe penetration through the weatherboards (Area B)
- the lack of sealing to the ensuite shower fittings (Area B)
- the ensuite extract fan is not vented to the outside (Area B)
- the lack of a grate to the gully trap outside the ensuite (Area B)
- the apparent lack of a terminal vent to the foul water drain.

- 5.3.4 I conclude that investigation and/or remedial work is necessary in respect of the following areas:
- In regard to Clause E2, the unsealed junctions at the:
 - jamb facings to the kitchen window (Area E)
 - bathroom water heater junctions with the wall cladding
 - ensuite toilet drain pipe penetration through the wall cladding (Area B)
 - In regard to Clause E3:
 - the unsealed ensuite shower fittings (Area B)
 - the lack of ducting to the outside of the ensuite extract fan (Area B)
 - deteriorating sealants to some junctions
 - In regard to Clause G4:
 - the ensuite extract fan does not appear to be vented to the outside
 - In regard to Clause G13:
 - verification of an open terminal vent to the foul water drain
 - the lack of a grate to the gully trap outside the ensuite.
