## Determination 2018/051

# The refusal to issue a code compliance certificate for a 9-year-old house with mixed claddings at 170 Pukehina Parade, Te Puke

This determination considers the compliance of a consented building where there was delay in completing the consented work. The determination considers the authority's reasons for declining to issue the code compliance certificate for the work; the authority's reasons were principally concerned with the building's compliance with Building Code Clause E2 — External moisture.

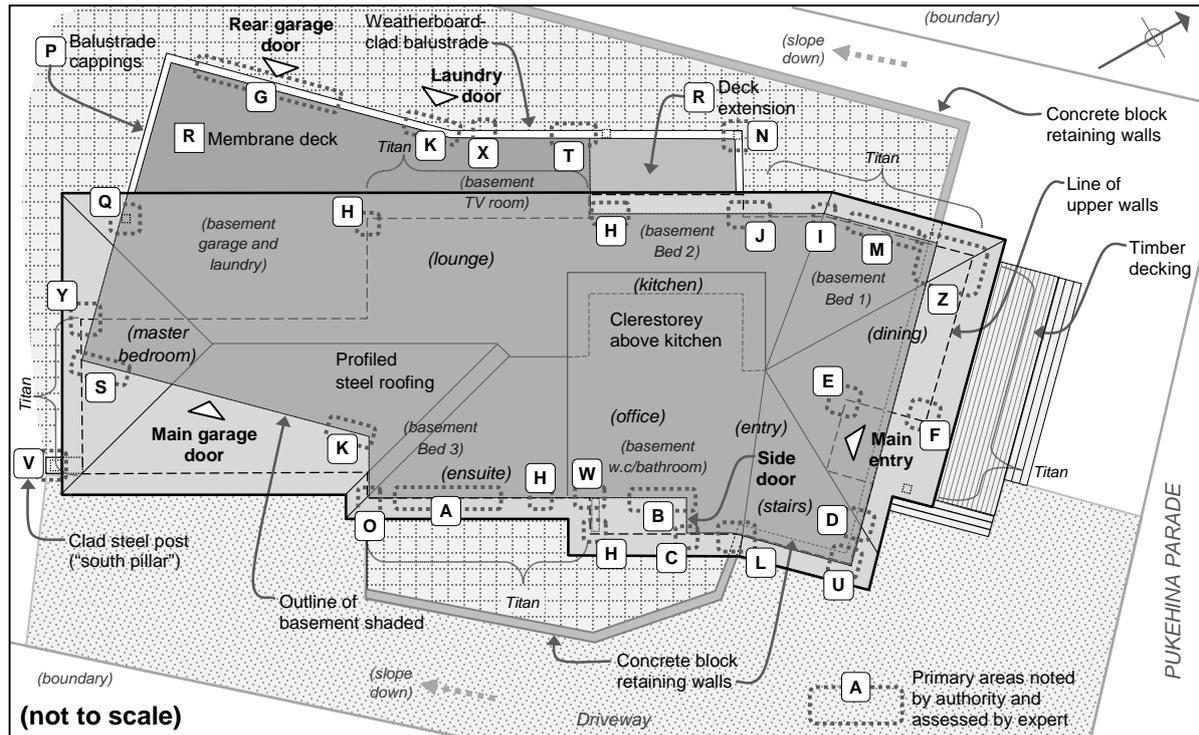
**Figure 1: Approximate site plan**

- Ends of head flashings (Areas A, B, D, E and F).
  - Bottom of cavities (Areas C, H, and O).
  - Condition of sheet cladding (Areas M and D).
  - Ground clearances (Areas K, L, N, S and Z).

- Deck membrane, junctions and balustrades (Areas J, P, R, Q and Y).
  - Joinery jamb/cladding junctions (Areas C, G, K, S and T).
- 3.5.3 In a letter to the applicants dated 18 January 2018, the authority refused to issue a code compliance certificate for the house, noting the meeting with the second building surveyor and stating:

- the steel post supporting upper south corner is framed and clad to form decorative pillar, with sheet cladding direct-fixed against building wrap and evidence of moisture entry and damage to framing (Area V).

- Condition of sheet cladding (Areas I, J):
  - there is a short unflashed horizontal junction at the head flashing (Area I)
  - there is a small diagonal crack at end of the head flashing (Area J)

- cladding with insufficient clearance is exposed beside the retaining wall so attention is required (Area L)
  - at northwest cladding to dining area, the cladding extends over the subfloor down to the mowing strip – risking moisture transferral via the adjacent retaining wall into the adjacent basement cavity (Area Z)

- direct-fixed cladding to posts supporting the deck extension butts against paving and moisture levels were elevated – although timber drillings appeared ‘in excellent condition’ with no indication of damage (Area N)

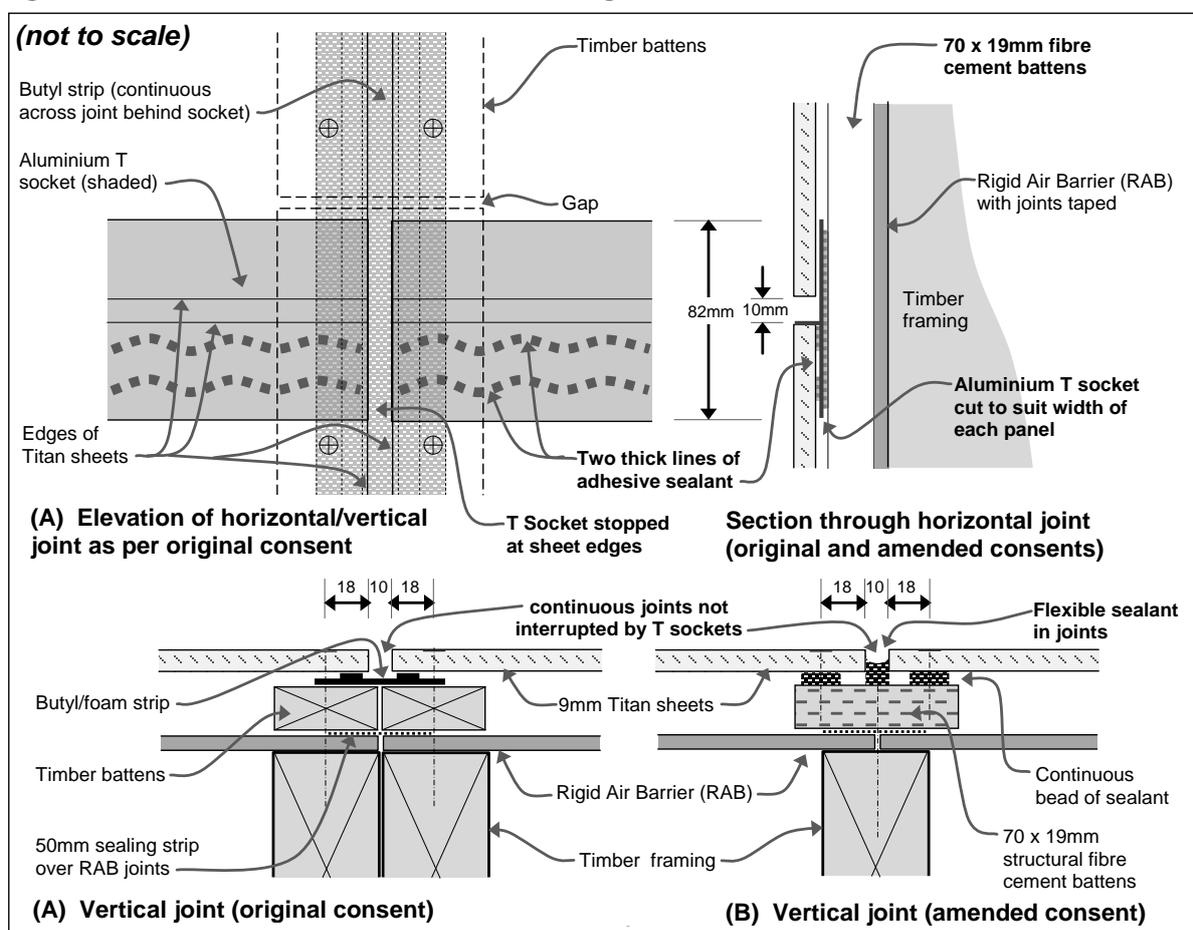
**Figure 2: General details in consent drawings**

- 2.7.2 The 2008 consent documentation included the manufacturer’s specification for the sheet cladding and the drawings included details from those specifications as shown in Figure 2(A) but the cladding was installed using structural battens and face-sealed joints. Amended vertical joints as shown in Figure 2(B) were retrospectively approved under the 2011 consent amendment.
- 2.7.3 The remaining walls are clad in 16mm thick proprietary horizontal fibre cement weatherboards fixed through battens and the building wrap to the framing timbers.

5.4.3 In regard to sheet cladding socket joints as installed (see Figure 2), the expert noted that:

- further investigation is needed to confirm the full extent of water penetration and possible damage before considering possible repair methods.
