## Determination 2019/037

# The refusal to issue a code compliance certificate for a 17-year-old house with a corrugated cellulose fibre cladding system at 7B Mayor View Terrace, Waihi Beach

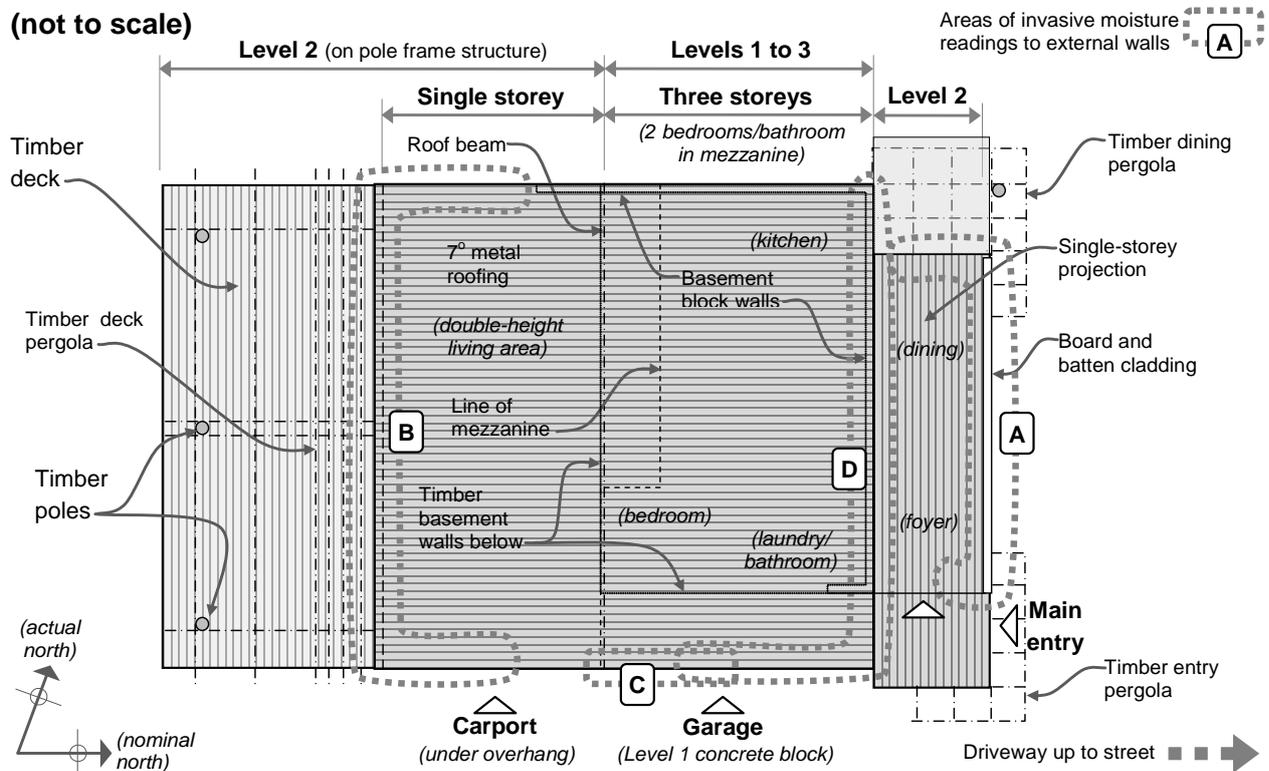
**Figure 1: Approximate layout of the house**

5.2.2 The building surveyor recorded the following invasive moisture readings from areas considered to be at risk of moisture penetration (refer Figure 1 for location of areas):

- Area A: Level 2 north single-storey lean-to (clad in board and batten):
  - 15% at north jamb to entry door
  - 14% and 15% beside the entry window
  - 13% to 15% beneath north window jambs
  - 15% at jambs to rear door.
- Area B: Level 2 south living area (with cellulose fibre cladding):
  - 12% and 13% at jambs to full height west window
  - 13% to 15% at jambs to north deck doors
  - 14% and 15% at jambs to full height east window.
- Area C: Level 2 east Bedroom 3 (with cellulose fibre cladding):
  - 12% to 16% beneath east window jambs.
- Area D: Level 3 north mezzanine (with cellulose fibre cladding):
  - 10% to 13% beneath east window jambs to Bedroom 1
  - 12% to 14% beneath north window jambs to Bedroom 1
  - 11% beneath north window jambs to Bedroom 2
  - 11% beneath north jamb to west window of Bedroom 2.
