Determination 2024/016

The issue of a notice to fix for building work associated with a two storey building with sanitary fixtures

10 Glenesk Road, Piha, Auckland

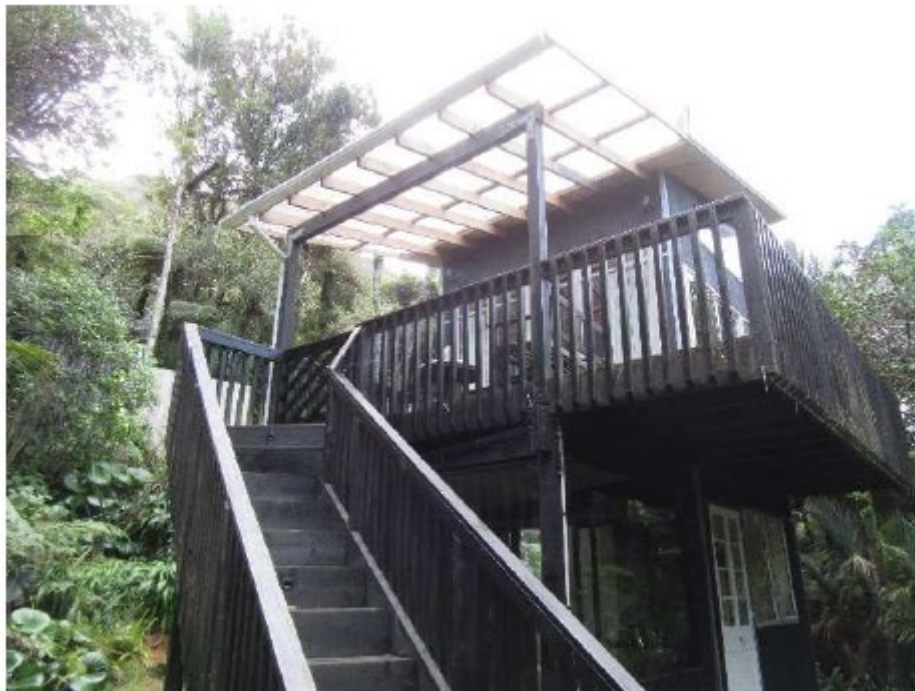
Figure 1: The building under consideration.

- 2.2. The building under consideration in this determination is a two storey “sleepout” with sanitary fixtures (see Figure 1). The owners state the building has a floor area² of 3.155m x 3.155m, ie slightly less than 10m².

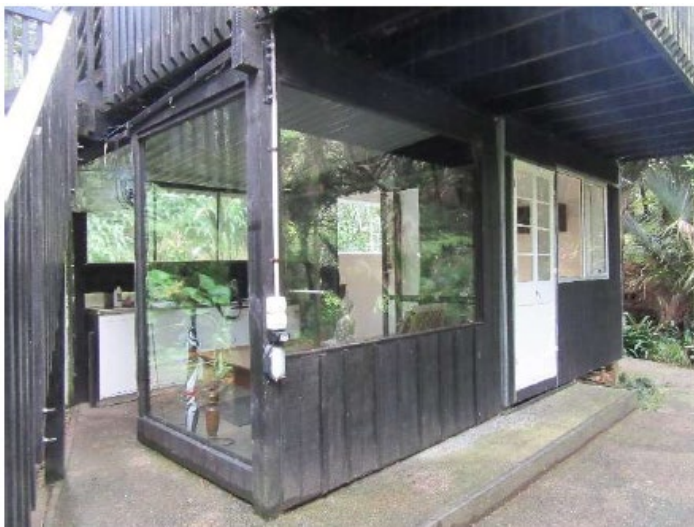
- 2.6. In the following years, the lower storey was progressively enclosed and sanitary fixtures were added.
- 2.7. The ground level now includes an enclosed living/office area. There is also a partially enclosed area (“the veranda”) with a kitchen sink, bench and cabinetry attached along one wall, and corrugated metal roof above (see Figure 2). The open end of this space has a plastic curtain.

Figure 2: Photograph showing partially enclosed area on ground level.

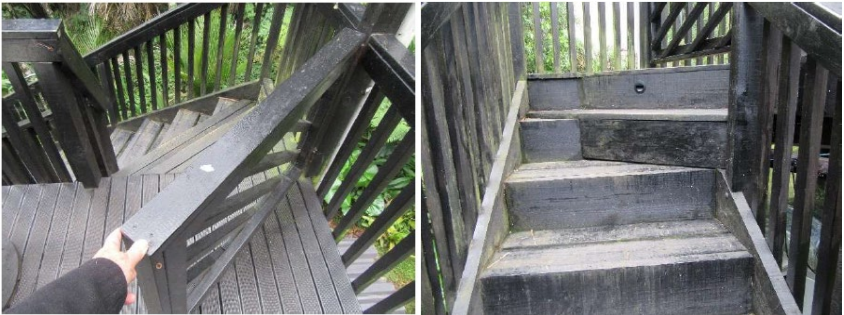
Item 2: “The constructed stairway in this building is too steep, there is no compliant handrail and the barrier is not constructed correctly contrary to clause D1 (Access), F4 (Safety from falling) of the NZ Building Code”	
The stairway is “too steep”	<ul style="list-style-type: none"> The notice to fix states that the stairway is “too steep”. The authority submits neither the stairs, the handrail, nor the “landing” (ie the winding step at the top of the stairs, see Figure 3) comply with the Building Code clause D1 Access Routes, specifically subclauses D1.3.3(f), (j) and (m). This is because the risers are too high, there is an absence of a graspable handrail, and the “landing” is an inadequate size for footfall. The authority also states that the barrier to the upper deck area is non-compliant (measuring 930mm high). The risers (other than at the top and bottom of the stairway) are approximately 250mm and the treads are approximately 400mm, resulting in a pitch of approximately 32°. Acceptable Solution D1/AS1

<p>provides that the maximum pitch for main private stairways is 37°. ³³ Therefore, the pitch of this stairway is within the parameters of the Acceptable Solution.</p> <ul style="list-style-type: none"> • However, performance clause D1.3.3(f) states: “Access routes shall: ... have stair treads... which... have uniform rise within each flight and for consecutive flights.” • The owners state “We acknowledge that there are differences in rise at each end of the stair but the code clause recognises (f) (ii) that a uniform rise <u>within each flight</u> is required...”. • In my view, the words “within each flight” include all of the risers up to the deck, including the winding steps. This interpretation is consistent with the objective at D1.1(a), to “safeguard people from injury during movement into, within and out of buildings”. A uniform rise is required within each flight (and for consecutive flights) to reduce the likelihood of users tripping. • In this case, the top and bottom risers are significantly higher than the others (approximately 280mm rather than 250mm). The Acceptable Solution comments that “The foot is normally only lifted a few mm above the treads during ascent. A minor variation in riser height can cause someone to stumble”. ³⁴ • The authority also stated, in its determination submission, that it considers the dimensions of the “landing” (ie the winding step at the top of the stairs) are non-compliant. However, as the notice to fix did not refer to this issue I have not commented on it.

<p>Figure 3: Photographs showing winding steps.</p>

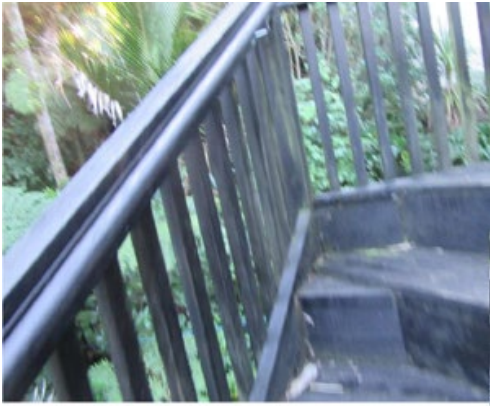
<p>Handrail to stairs</p>	<ul style="list-style-type: none"> • The authority states “There is the absence of a graspable handrail with only an under-height balustrade (less than 1m) to navigate the stairs...”. • The owners state that the handrail was remedied, and the authority was informed of this on 7 September 2020. The owners have provided a photo showing a new handrail installed to the inside of the stairway balustrade (see Figure 4). • Clause D1.3.3(j) states “Access routes shall: have smooth, reachable and graspable handrails to provide support and to assist with movement along a stair or ladder” [my emphasis]. • In this case, I have not been provided any relevant dimensions of the handrail, including its height from the pitchline, its width and its clearance

<p>from the balustrade. As such, I do not have enough information to comment on this.</p>

<p>Figure 4: Photograph showing the stairway balustrade, including the new handrail.</p>
Barrier to deck	<ul style="list-style-type: none"> • The authority states “Another non-compliance is the barrier off the upper deck area which measures 930mm...”. • The owners state that the barrier was remedied, and the authority was informed of this on 7 September 2020. The owners have provided a photo which shows the current height of the barrier (approximately 1020mm) (see Figure 5). • Clause F4.3.1 states “Where people could fall 1 metre or more from an opening in the external envelope or floor of a building, or from a sudden change of level within or associated with a building, a barrier shall be provided”. • Clause F4.3.4(b) states that “Barriers shall... be of appropriate height”. • The photograph showing the side of the barrier shown (Figure 5) suggests the height complies with F4.3.4(b) via the Acceptable Solution, which provides for a minimum barrier height of 1000mm.³⁵ However, no evidence has been provided to confirm that the other sides have been remedied, and therefore, I cannot comment on the barrier as a whole. • The authority’s determination submission also noted that the internal mezzanine area “does not appear to have a barrier where one is required”. However, the notice to fix did not refer to the lack of barrier for the internal mezzanine area. As such, I offer no further comment on this.³⁶

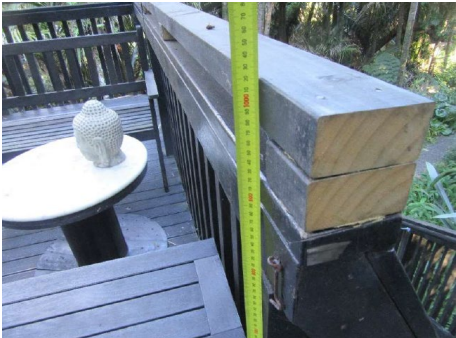
<p>Figure 5: Photograph showing the current height of the barrier (1020mm).</p>

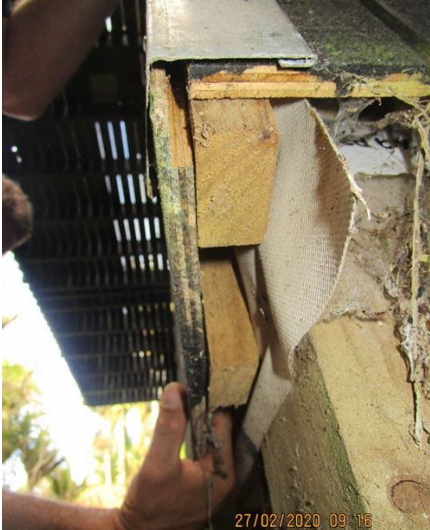
Item 3: “This buildings cladding system, has not been installed to the necessary requirements, contrary to clause E2 (External moisture) of the NZ Building Code”	
Flashings	<ul style="list-style-type: none"> The authority’s submission states: The detailing of the vertical shiplap lacks adequate flashings between the cladding and the raked soffits, inter-storey junctions and internal/external corners. The window head flashings lack upstands... The authority has provided photos from its inspections showing the exterior of the windows and the building, as well as one photo showing an external corner (see Figure 6). It is not clear which windows the authority is referring to, or whether it is all of them. I do not have enough information reach a conclusion on compliance of these items.

<p>Figure 6: Photo of an external corner, looking upwards towards the second storey deck.</p>
Lack of cavity to second storey	<ul style="list-style-type: none"> The authority states “The ply shadow-clad product is installed to the second storey with no evidence of a cavity nor vermin protection”. The owner states that Figure 6 shows clear evidence of cavity battens, but this photo appears to show the lower storey. The authority has not provided sufficient information about why this detail does not comply with the relevant performance clause, and I do not have enough information comment on this item.

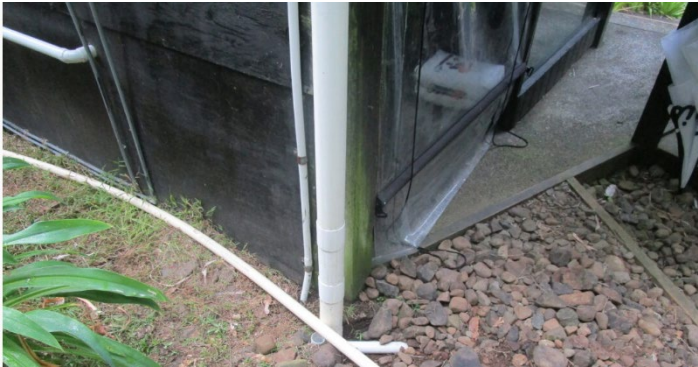
The ply in the kitchen area	<ul style="list-style-type: none"> The authority states “The ply is in connection with the ground at the edge of the kitchen area which allows water movement up the wall by wicking. Compliant cladding clearance has not been achieved...”. Performance clause E2.3.3 states “Walls, floors, and structural elements in contact with, or in close proximity to, the ground must not absorb or transmit moisture in quantities that could cause undue dampness, damage to <i>building elements</i>, or both.”

<ul style="list-style-type: none"> As there is no clearance between the ply wall and the ground (see Figure 7), the ply is likely to absorb moisture causing undue dampness and damage to the ply wall.

<p>Figure 7: Photograph showing ply wall in connection with the ground.</p>
The plastic sheet with zip in the kitchen area	<ul style="list-style-type: none"> The authority states “The kitchen area is deemed a habitable space and currently only protected with a clear plastic sheeting with a black zip that fails to keep water out which is deemed non-compliant...”. Performance clause E2.3.2 states: “Roofs and exterior walls must prevent the penetration of water that could cause undue dampness, damage to <i>building elements</i>, or both”. I acknowledge the authority’s submission that “Kitchen cupboards are mouldy”. I note that considering whether there is “damage to building elements”, this would require consideration of whether the kitchen cupboards are fixtures as defined in clause A2. I do not have sufficient information to comment on whether the cupboards are in fact fixtures. The authority also noted that this kitchen area is “deemed a habitable space”³⁷ and referenced Clause G5 Interior environment and to storage of food and access by vermin. I note various code obligations arise with regard to habitable spaces, such as E3.3.1, and G5.3.1. and that performance criteria for food preparation facilities apply to housing. However, these issues were not raised in the notice to fix and so I have not commented further on these issues.
