Determination 2024/042

Regarding the compliance of external timber wall cladding

107a Main Road, Fairfield, Dunedin

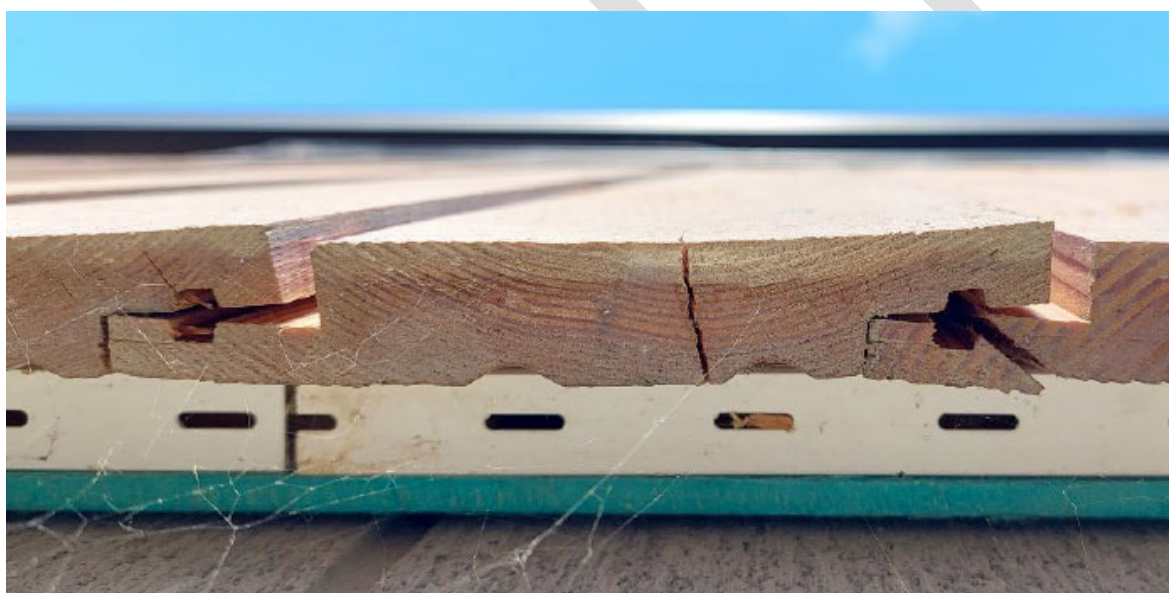
Figure 1: View of underside of cladding, west elevation

- 1.2.4. C Cockburn, the second LBP who carried out the installation of the wall cladding (“the second LBP’).
- 1.3. This determination arises from defects to the external vertical shiplap timber wall cladding (“**the cladding**”) installed on the dwelling at 107a Main Road, Fairfield, Dunedin, pursuant to building consent ABA-2020-1331. Refer to figure 1.²

- cupping⁹ and delamination of the weatherboards
 - long cracks and splits on the edges and down the centre of the boards, with some extending through the full thickness of the weatherboard

- knots with splits and holes wider than 2mm, bark and resin pockets in the wood, loose and missing knots, and some holes that extend through the weatherboards

- the construction of the external corners did not comply with the building consent documentation, there are cracks and splitting in the butt joints, and incorrect type and location of the fixings used.

- 4.10. The evidence made available to me by the owners and building surveyor indicate a range of defects with the cladding (refer to paragraphs 2.8 and 2.9). These defects allow water to enter into the cavity space behind the cladding and are situated across wide areas of the cladding leading me to conclude there will be significant water ingress beyond what would be expected from small gaps requiring normal maintenance. For example, there are full depth holes in the weatherboards and cupping of the timber opening the vertical joints. Similar defects also allow for the entry and absorption of water that is likely to accelerate the premature deterioration of the weatherboards, for example, where the timber is split, and this will exacerbate the problem of water ingress.

- 4.11. Further, although the building consent documentation refers to compliance of the cladding with NZS 3602 and NZS 3631 (see paragraphs 2.3 and 2.4), evidence indicates this has not been met. For example, holes, resin and bark pockets are evident in the weatherboard’s contrary to clause 111.2.3 of NZS 3602, and some surface checks exceed 100mm in length contrary to section 4.4.1.1 of NZS 3631.

condition of the cladding against the test in E2.3.2. The nature and extent of the various defects are such the exterior walls of the dwelling do not prevent the penetration of water that will cause undue dampness and damage to building elements. This includes the potential for the absorption of external moisture into the open checks, holes, and splits in the cladding that is likely to affect the durability of the timber to the extent compliance with clause B2.3.1(b) will not be satisfied without additional building work beyond what would be expected for normal maintenance.
