Determination 2024/050

Regarding compliance with the Building Code and the issue of a code compliance certificate for building work associated with a new dwelling

4 Valley Heights Lane, Auckland

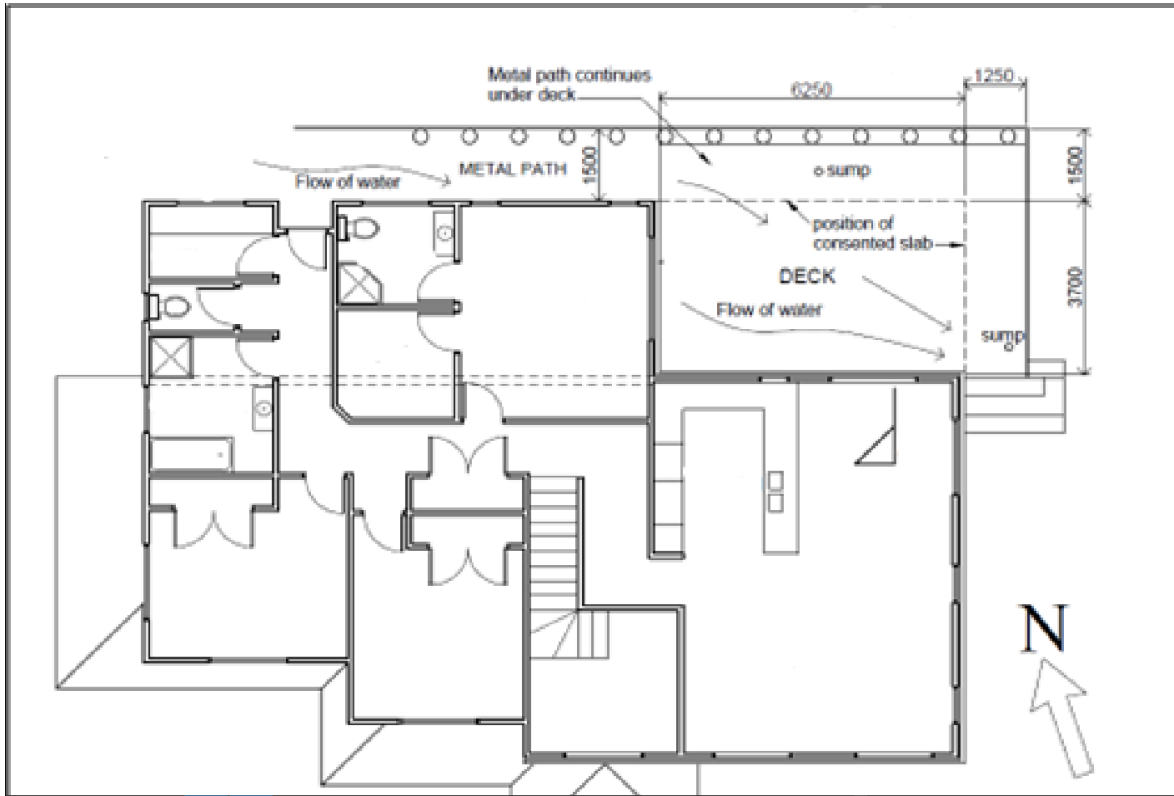
Figure 2: Upper level floor plan showing location of the deck

- 2.4. During construction a 6.25m x 3.70m timber deck was built in place of the patio (see Figure 2 'position of consented slab'). The timber deck was later extended over the metal path, and now measures approximately 7.50m x 5.20m. Timber stairs off the southeast of the deck follow the contour of the ground.

- 2.7. The surface water drainage system in the vicinity of the deck consists of downpipes, pipework, drains and a sump (Figure 2).⁴ The surface water appears to discharge to the ground under and around the deck area and travels toward the east of the site and down that side of the building.

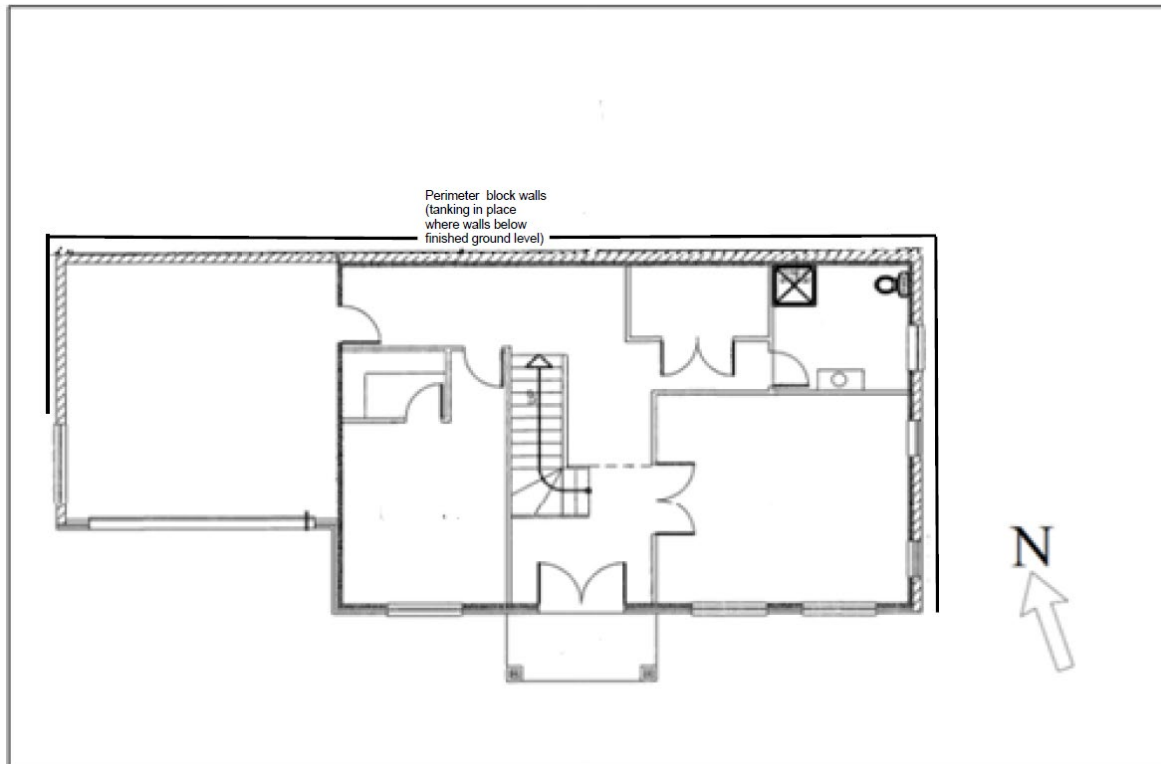
Figure 3: Lower level showing block foundation walls

- 2.2. Approximately one quarter of the upper level is founded on a slab foundation which is supported by a perimeter footing and a concrete block retaining wall (“the block wall”) which can be seen in Figures 2 and 3. The block walls have a waterproofing tanking applied below ground level and sub-soil drainage at the base of the wall. The remaining upper-level floor structure consists of a timber joist and steel beam mid-floor generally following the outline of the lower level.
- 2.3. The approved building consent drawings specified a “deck” on the upper-level floor plan to the northeast of the dwelling, accessed off the dining room. But the floor framing and foundation plan and cross section ‘A’ specified a 100mm thick concrete slab (“the patio”) supported by what appears to be a block foundation edge.
