Determination 2024/051

Compliance of roof cladding on a house with clause E2 External moisture

57A Bayview Road, Charteris Bay, Governors Bay

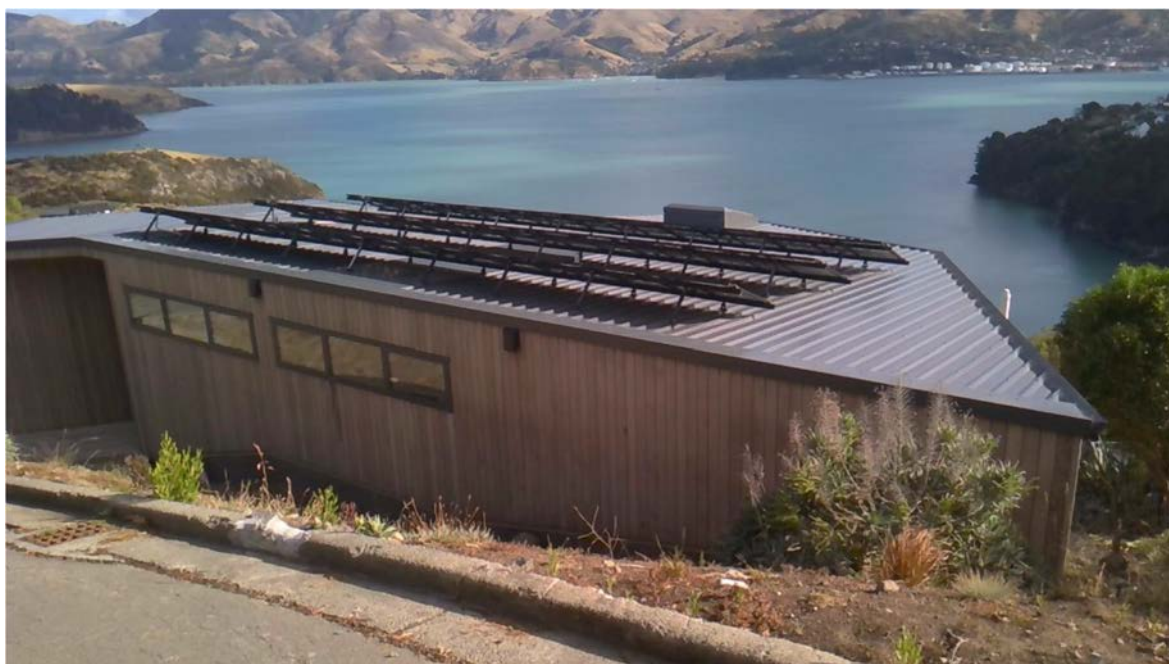
Figure 1: Rear elevation of dwelling looking northwest¹

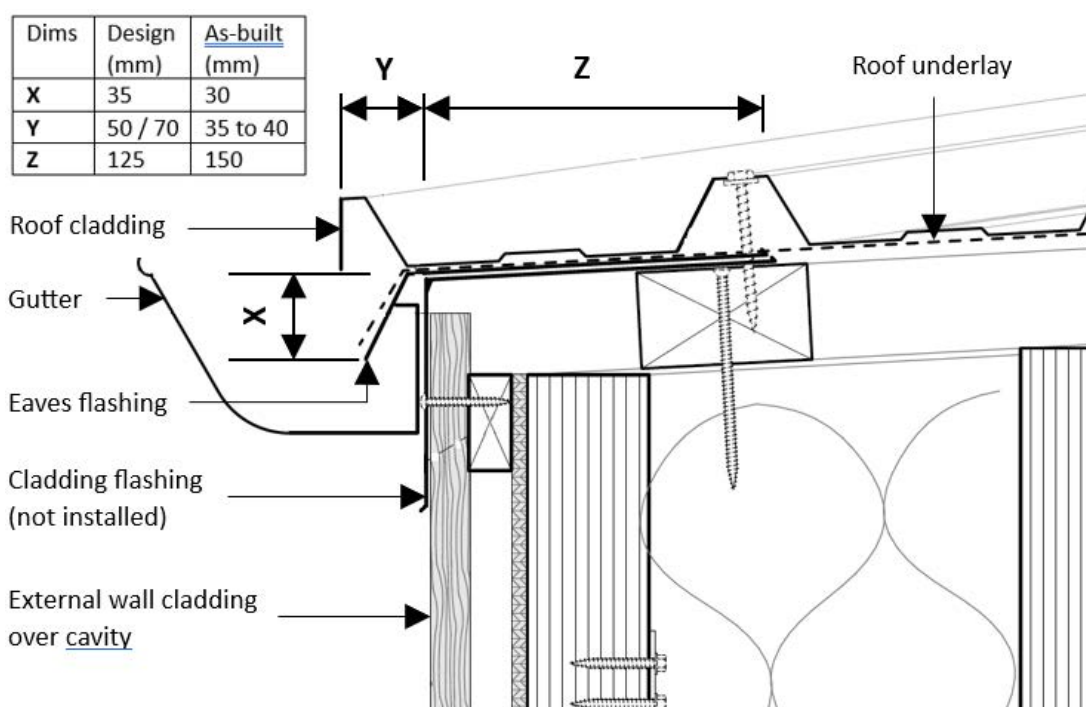
Figure 2: Eaves construction¹⁰ (not to scale)

- 2.12. Several changes were made during the installation of the roof cladding system that departed from the building consent plans and specifications, including:
- 2.12.1. substituting an alternative lightweight trapezoidal (asymmetrical) proprietary metal roof cladding system
 - 2.12.2. substituting an alternative eaves flashing
 - 2.12.3. not installing the cladding flashing

¹⁰ Figure 2 has been reproduced from building consent plan A-20, detail D-1. It does not show the as-built gutter guard. The "Design" dimensions were taken from Acceptable Solution E2/AS1, the NZMRM code of practice, and manufacturer's instructions. The "As-built" dimensions were provided by the owners and the builder and are approximate.

4.6. Some elements of the building work have not been completed in accordance with the building consent.²⁰ For example, the specified cladding flashing has not been installed, and the turn-downs to the edge of the roof sheets have not been formed.
