Determination 2024/052

Regarding the issue of a dangerous building notice for a residential dwelling, water tank, deck and stairs

2 Welsh Hills Road, Swanson, Auckland

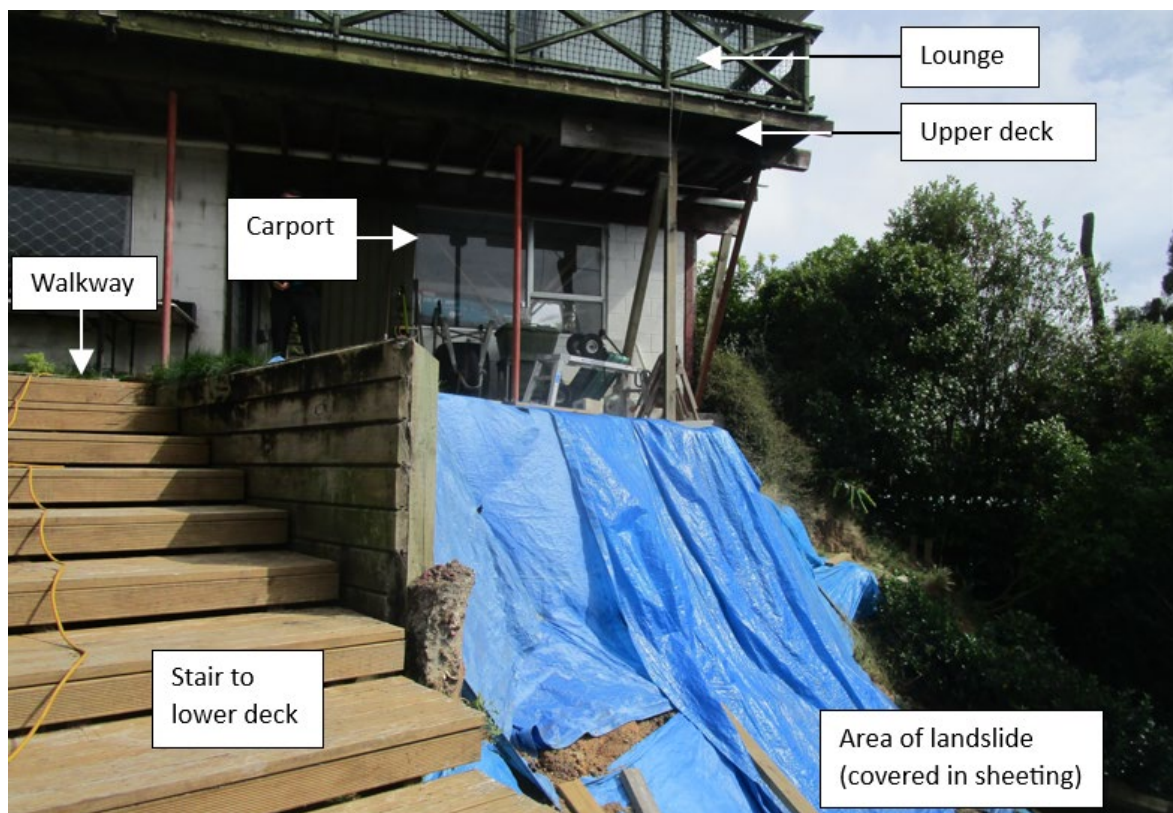
Figure 1. Part of landslide on the east side of the dwelling

- 1.4. The notice was issued following a landslide in August 2021, which occurred close to the north and east sides of the dwelling (refer to Figure 1²), a timber deck and associated access stairs, and a water tank.

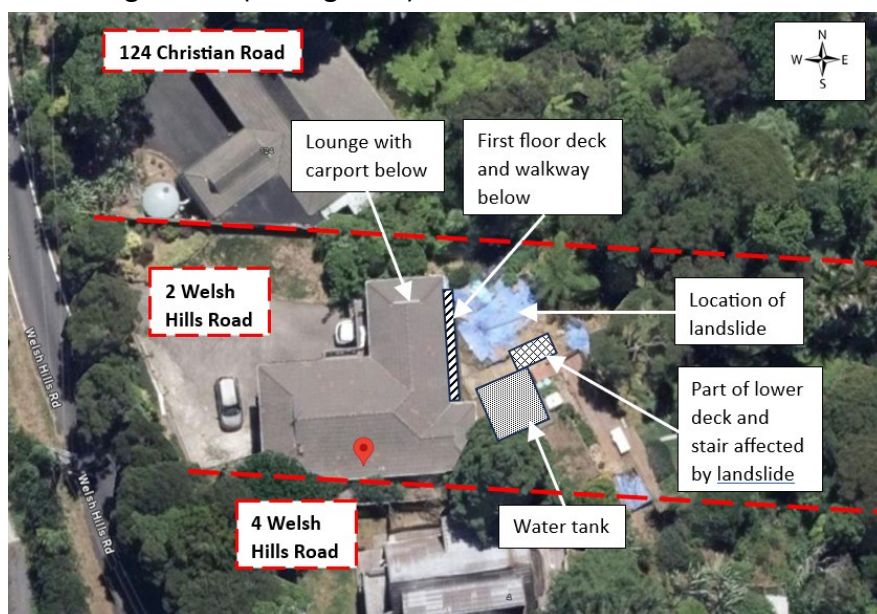
Figure 2. Aerial view (not to scale)⁵

- 2.1. The property is in a rural location near Auckland. The two-storey dwelling sits on a level platform, and the ground generally slopes down to the east towards an area of dense vegetation (see Figure 2).

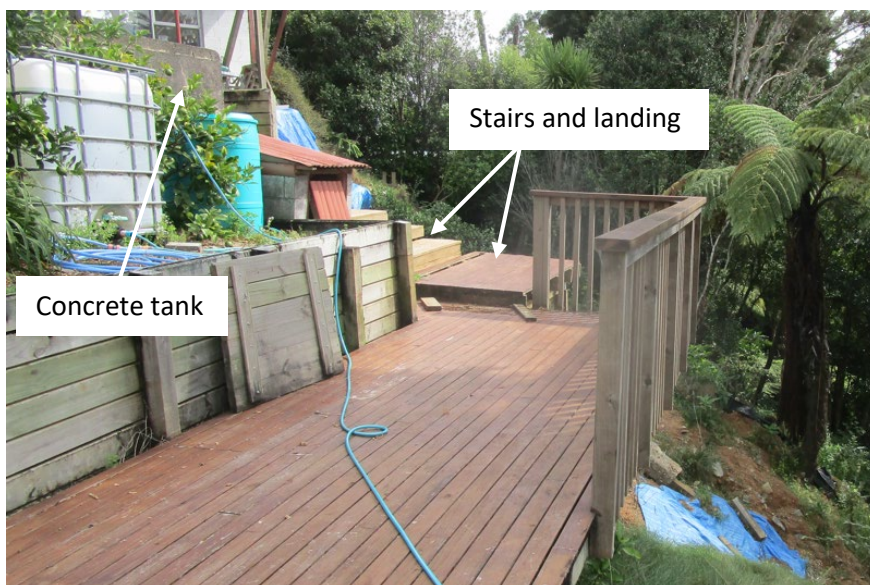
water tank has any foundations. There is a timber post and board retaining wall between the water tank and the deck below (see Figure 3 below).

- 2.9. A timber stair near the water tank leads down to a timber deck supported on timber piles. The owner advised the piles were fixed into non-engineered fill which moved during the landslide. It appears that prior to the landslide there was a barrier to two sides of the landing at the north end of the deck.⁷

Figure 3. View of lower deck and landing

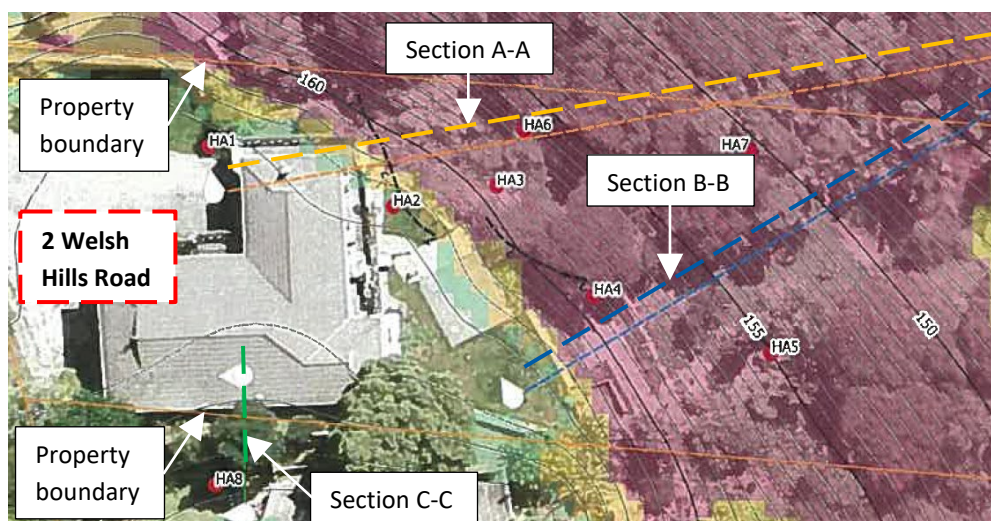
- (3) depths of fill material between 400mm and 800mm to the east of the dwelling and lower deck (HA3, HA4 and HA6)
- 3.4.6. the topsoil and fill are unsuitable to support permanent structures due to the potential for differential settlement.

Figure 4. Hand auger locations and contour lines¹²

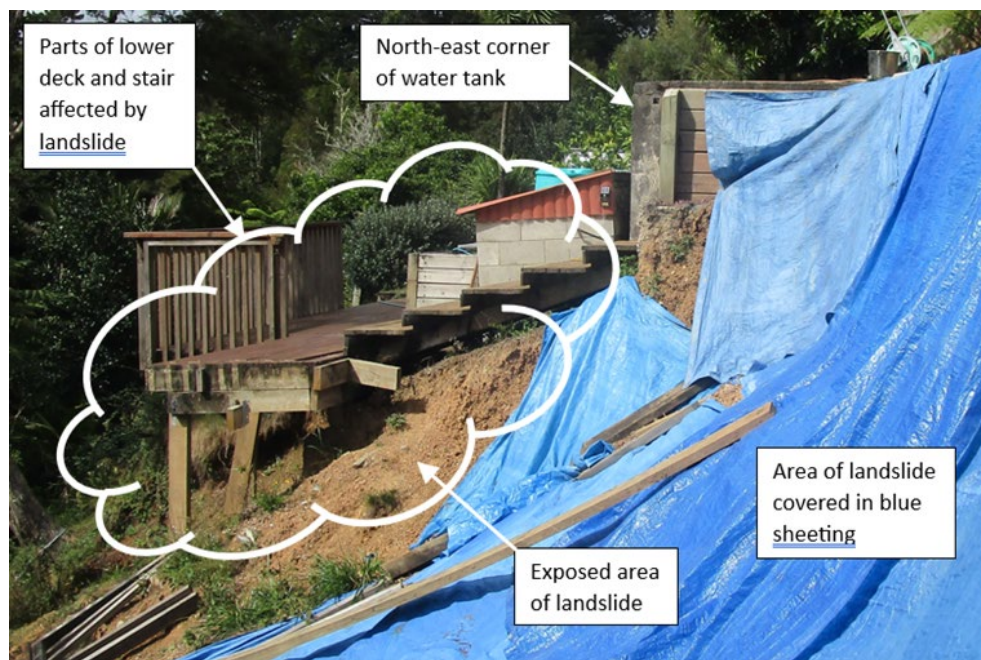
- 3.5. On 5 April 2022, the authority visited the site to investigate a landslide “affecting the property and potentially the building”. See figure 5.

Figure 5. Lower deck, access stair and water tank¹³
