Determination 2024/068

The issue of a notice to fix for a deck constructed without a building consent.

5/24 Eastglen Road, Glen Eden, Auckland

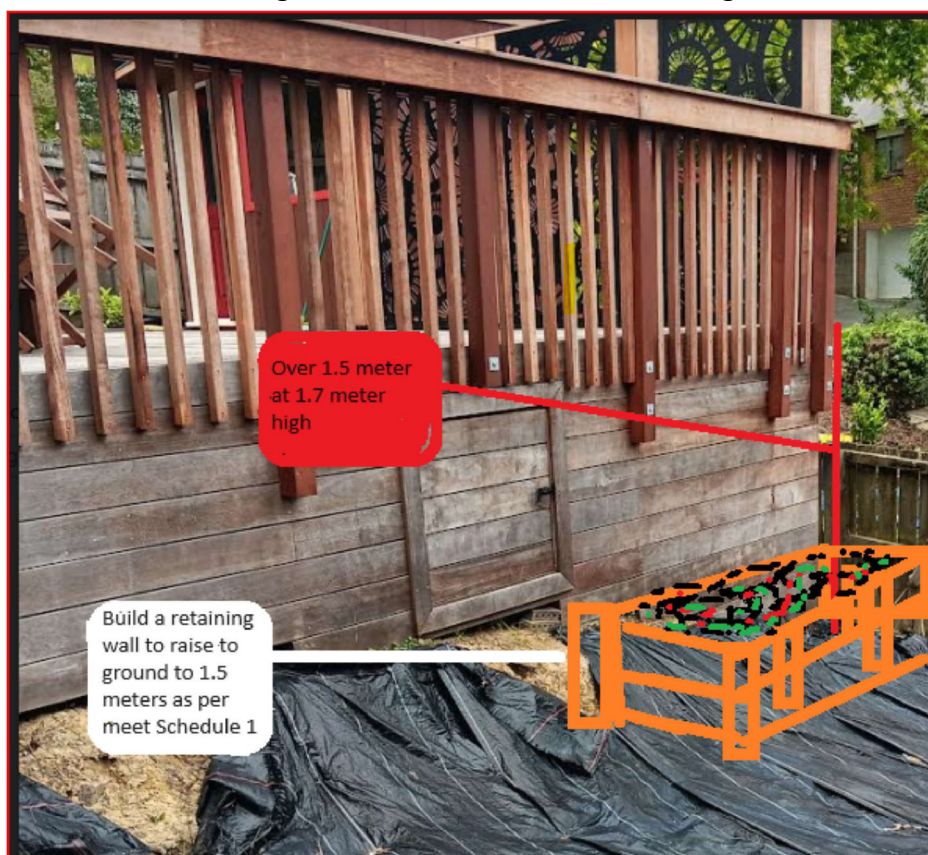
- 3.5. In response to the issue of the notices to fix, the owners engaged a building surveyor ("the building surveyor") to assist them in responding and taking steps of remediation works in their attempt to achieving compliance. The building surveyor provided a report on 21 February 2024. The report included an annotated photograph stating that at its highest point, in the northeastern corner, the deck was 1.7m above the ground level below, as shown in Figure 1.

Figure 1. Building surveyor's annotated photo showing maximum height of deck

- 5.12. In the first report dated 21 February 2024, the building surveyor acknowledged that the highest point of the deck (in its northeastern corner) was at 1.7m above the

ground level, indicating this on an annotated photo (see Figure 1). In the second report dated 2 April 2024, the building surveyor advised the height of the deck had been resolved by changing the surrounding ground level.

- 5.13. I have concluded that the height of the deck at its northeastern corner, and possibly at other points along that adjoining sides, is more than 1.5m above the level of the ground under the deck. This ground level would have been similar to that on the outside of the deck before the landscaping was done, which both parties' measurements have confirmed was over 1.5m.

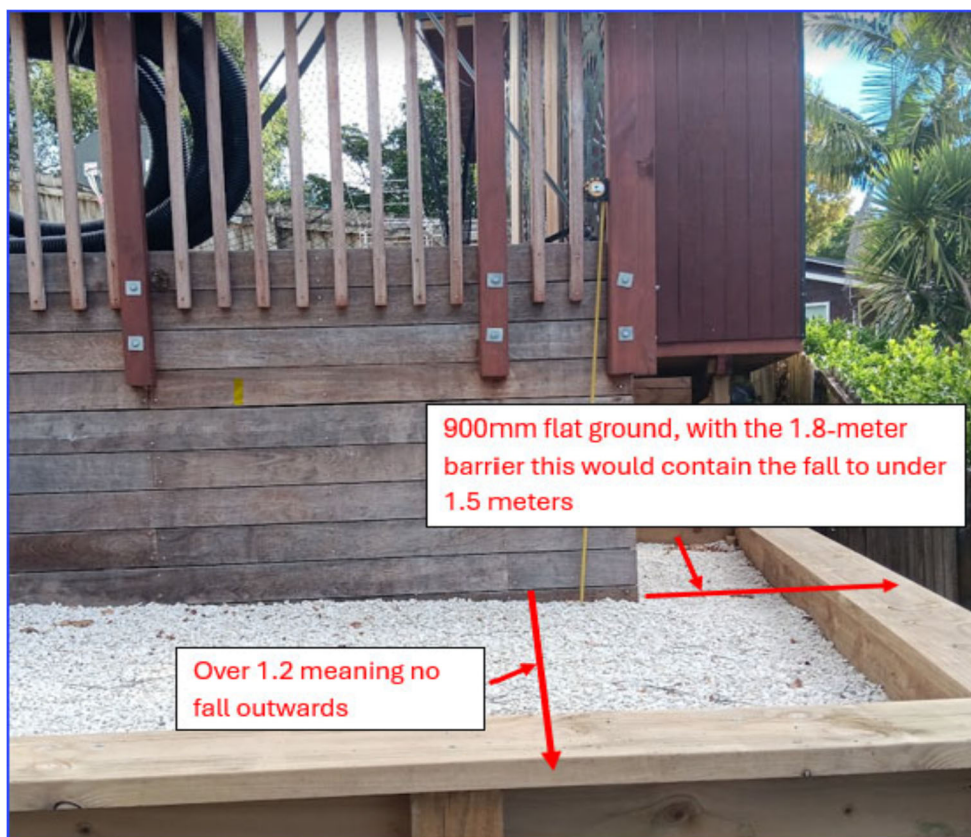
Figure 2. Building surveyor's annotated photo showing width of raised area constructed below deck

- 5.17. I note also that the building surveyor has made submissions about the width of the raised garden planter beds and retained level area in front of the deck's eastern side (which is stated as 1.2m wide) and that the width is sufficient to break a person's fall should there be a collapse from the edge of the deck in this location.

- 5.18. A similar garden planter bed or retained raised area has been constructed on the deck's northern side. The photos supplied by the building surveyor indicate that this garden planter bed and raised area are significantly narrower than the one on the eastern side (due to the proximity of the boundary), particularly in the area adjacent to the deck's northeastern corner. The building surveyor has advised that this garden planter bed or retained raised area is 900mm wide, although it is unclear if this is at its widest point as the width of the bed or area appear to vary.

- 5.19. I consider the ground level beyond the northern retained garden planter beds has been excavated or levelled, and that although no exact measurements have been given, the height of the raised area is well over 0.5m high in this area.
- 5.20. In my view, in the absence of accurate measurements, it is not clear that a person standing near the northeastern corner of the deck could not fall more than 1.5m if they fell outwards in a northern direction, let alone falling inwards or downwards, in the event of the deck collapsing. The width of the raised retained area is potentially insufficiently wide in this location to break a person's fall. The height of the raised garden planter bed below the surface of the deck (1.38m) when combined with the height of the retained raised area itself (at least 0.5m) mean that the potential fall in this case would exceed 1.8m.
