Determination 2022/008

Regarding the compliance of a timber retaining wall with Building Code clauses B1 Structure and E1 Surface Water with respect to the protection of other property

7 Abbots Way, Remuera, Auckland

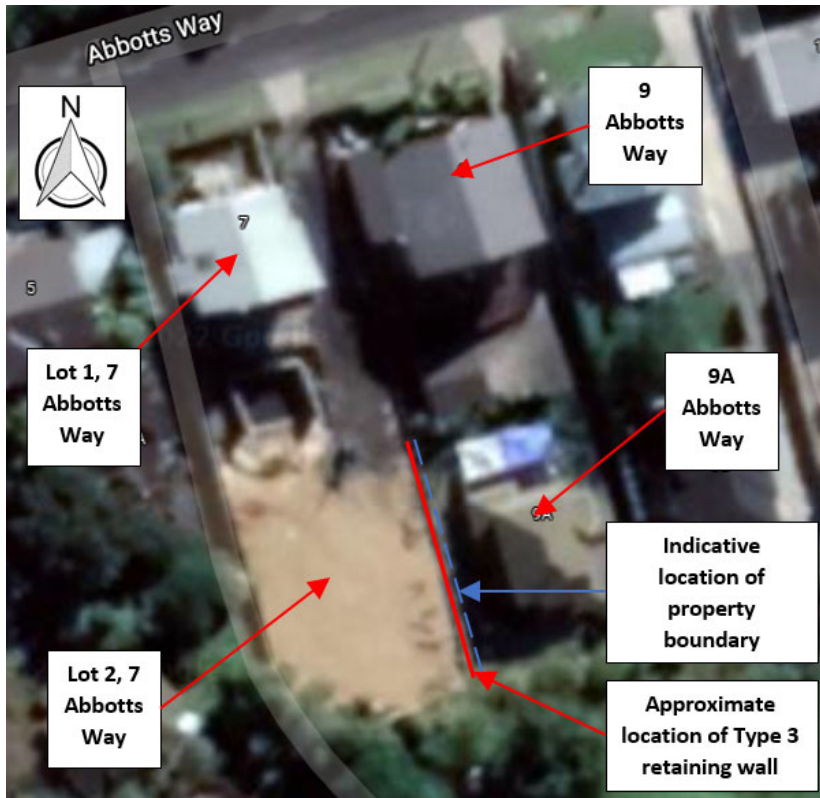
Figure 1: Aerial view¹² (not to scale).

- 2.3. Lot 2 of the 7 Abbots Way property ("lot 2") is at the rear of the property. The Type 3 retaining wall is constructed on lot 2 and is parallel and adjacent to the eastern boundary. This corresponds with the western boundary of 9A Abbots Way. See figure 1.

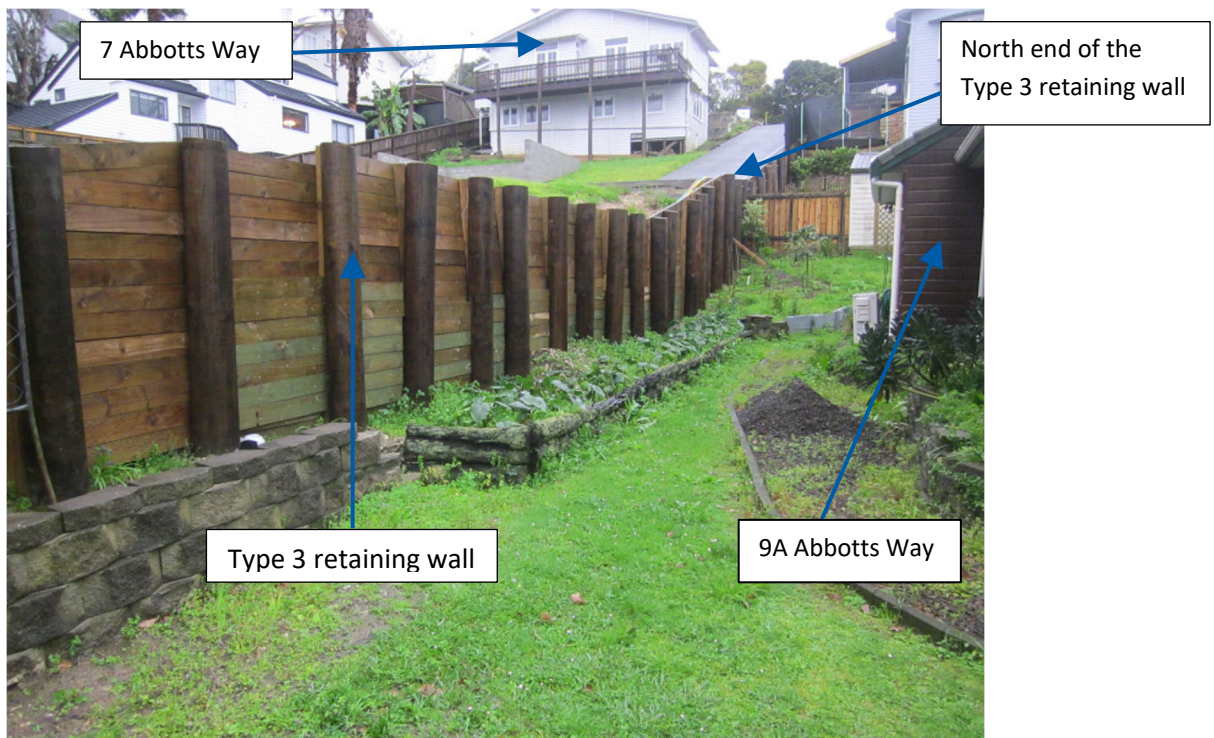
Figure 2: 7 and 9A Abbotts Way, and the Type 3 retaining wall.¹⁴

low height timber retaining wall and proprietary interlocking concrete block garden wall, close to the base of the Type 3 retaining wall. See figure 2.

- 3.12.1. A varying quantity of water can be observed at the toe, or base, of the Type 3 retaining wall and on the grassed area adjacent to the raised planter bed. The water appears to be localised to an area nearest to the Type 3 retaining wall, and it does not cover all of the lower grassed area or the raised planter (see figure 2).

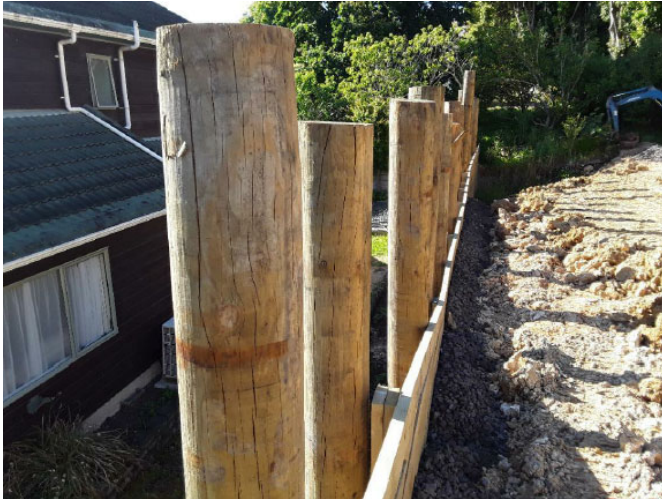
Figure 6: The Type 3 retaining wall as at 16 November 2018.³³

- 3.9. Also on 16 November 2018, the authority conducted an inspection in relation to building consent BCO10257508. The inspection report included a photograph of the partially constructed Type 3 retaining wall (see figure 6) and noted:

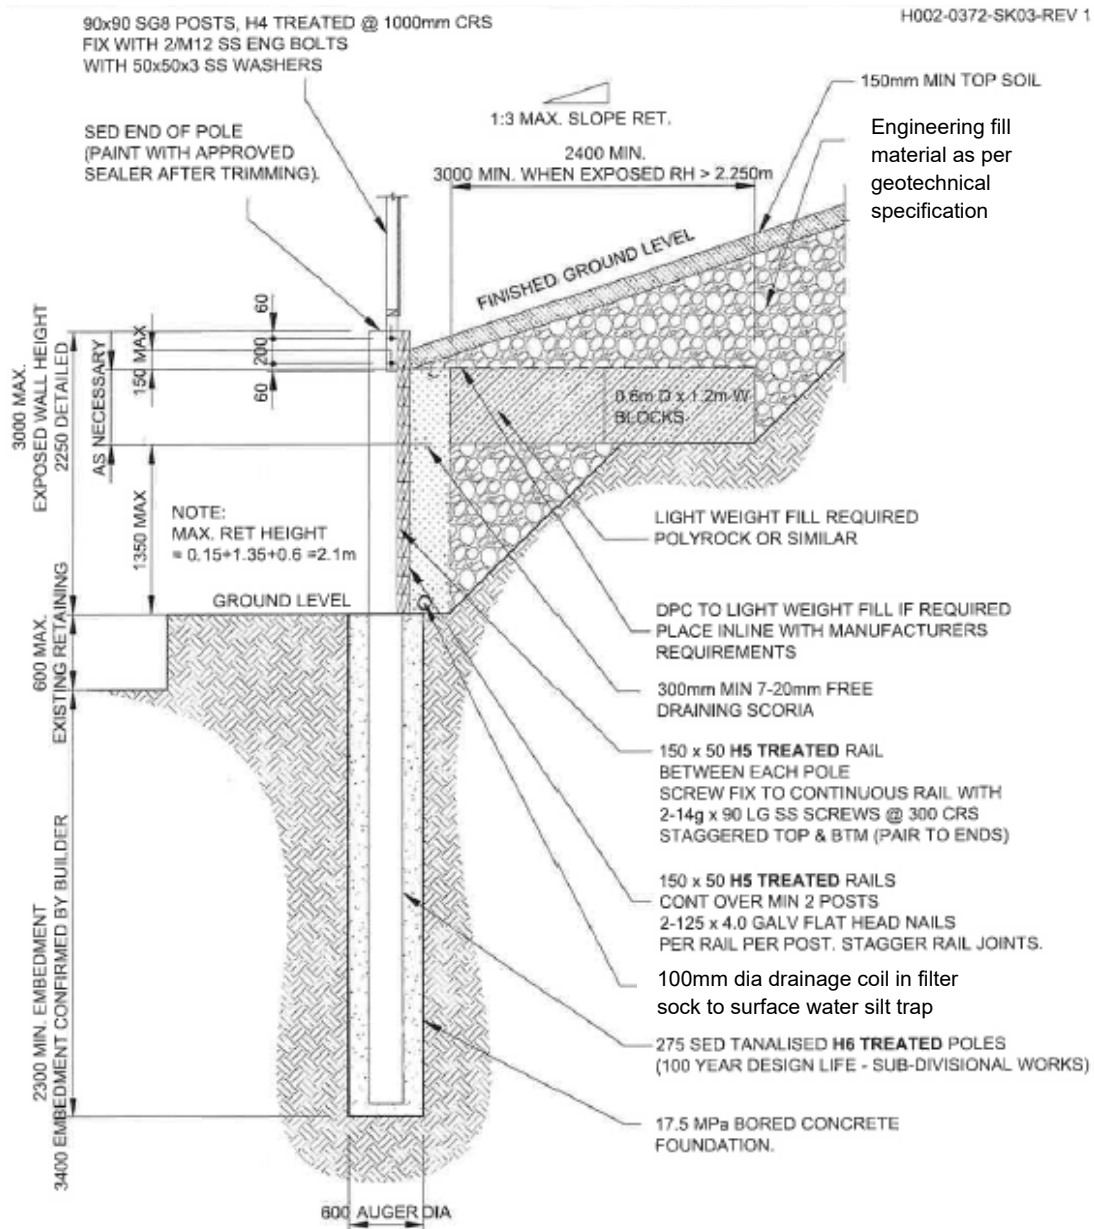
Figure 8: As-built detail for the Type 3 retaining wall.⁴¹

- 3.22.4. pole centres vary between 800mm to 1.5m, as noted in inspection report dated 10 December 2018
- 3.22.5. the poles are offset by up to 150mm from the wall facing, as noted in the inspection report dated 10 December 2018

- 3.22.6. the height of the Type 3 retaining wall varied from 2.1m to 3.2m, as noted in the inspection report dated 10 December 2018.
- 3.23. On 30 April 2021, the authority carried out a final inspection in respect of the retaining walls and drainage. The authority’s notes state a PS4 for the foundation has been submitted, that elements including the retaining walls appear to be in place as per the consented plan, and there were no issues identified during the inspection. The authority’s inspection report included a photograph of the as-built Type 3 retaining wall (see figure 9). The authority then issued a code compliance certificate on 13 July 2021 (see paragraph 1.14).

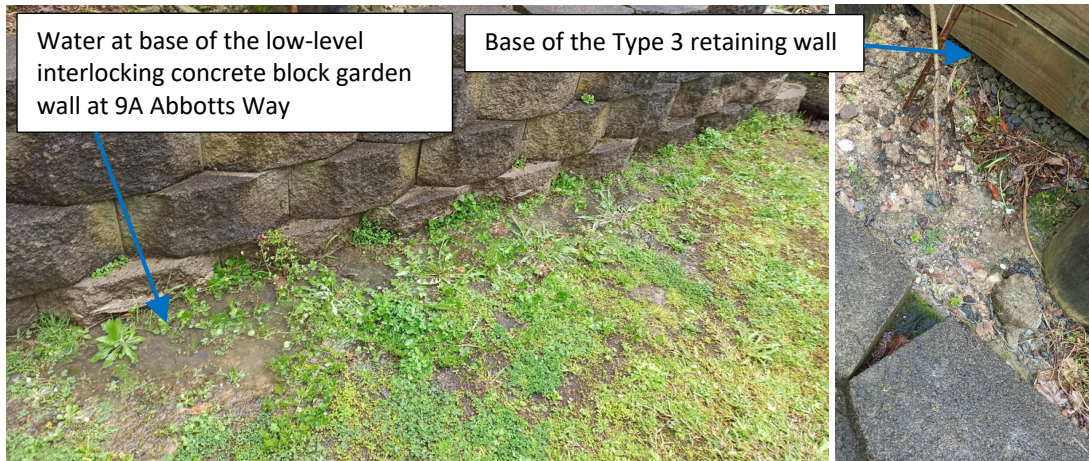
Figure 10: Extent of reported flooding on 23 September 2021.⁴⁴

3.24. On 23 September 2021, the applicant reported flooding in the backyard of 9A Abbotts Way to the authority. The applicant provided photographs taken on 23 September 2021 (see figure 10). No information has been provided to establish if the rainfall event on or about the 23 September 2021 met the criteria in clause E1.3.1 of an event having a 10 percent probability of occurring annually.⁴³

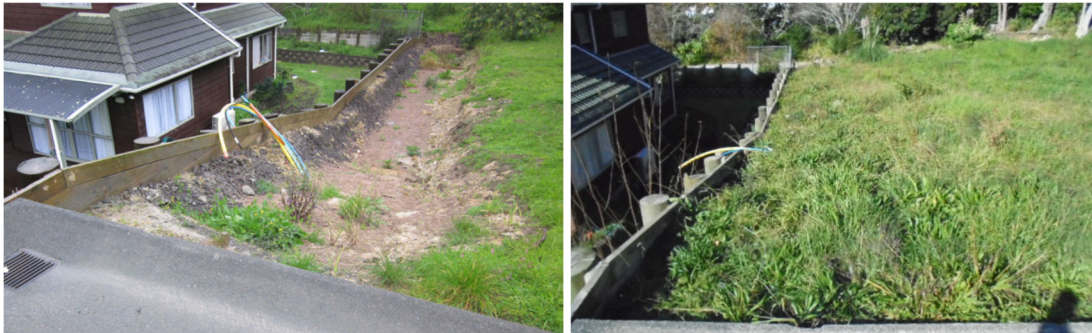
Figure 11: Site conditions.⁵²

- 5.4. At the time of the first site visit, the Type 3 retaining wall was only partially backfilled (see figure 11(a)), and the expert observed some scoria drainage material behind the wall. At the time of the second site visit, the area behind the wall had been backfilled and "the ground cover had become more substantial and denser, and therefore having an increased capacity for infiltration and reducing surface water flow". See figure 11(b).

(a) Site as at 11 August 2020

(b) Site as at 1 June 2021

- 5.9. At the first site visit, the expert noted the wall had not been fully backfilled, effectively leaving a swale behind the Type 3 retaining wall (see figure 11(a)). The expert noted there was some grass cover regenerating to the remainder of the site, but when previous surface water runoff had occurred during construction, the ground cover would have been minimal as the site had been stripped bare for the siteworks.
- 5.10. The expert had viewed the photographs and videos provided by the applicant (see paragraph 3.12). The expert noted:
