Determination 2021/012

Regarding alterations to install insulation in a skillion roof at 96 Lochiel Branxholme Road, Lochiel, Winton

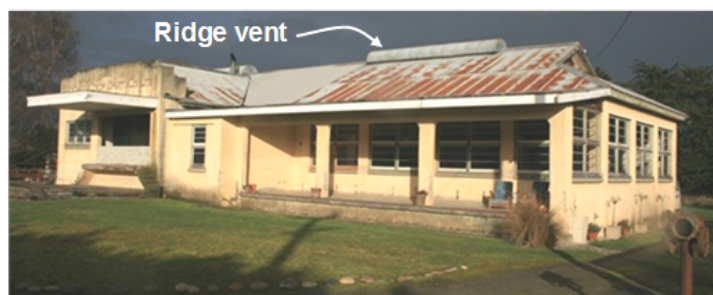
Figure 2: The original cheese factory

2.2.1 The building was originally constructed as a cheese factory in the mid-1930s as one of many co-operatives similar in plan, form and function built in New Zealand. Figure 2 indicates the condition of the factory by about the late 1990s.

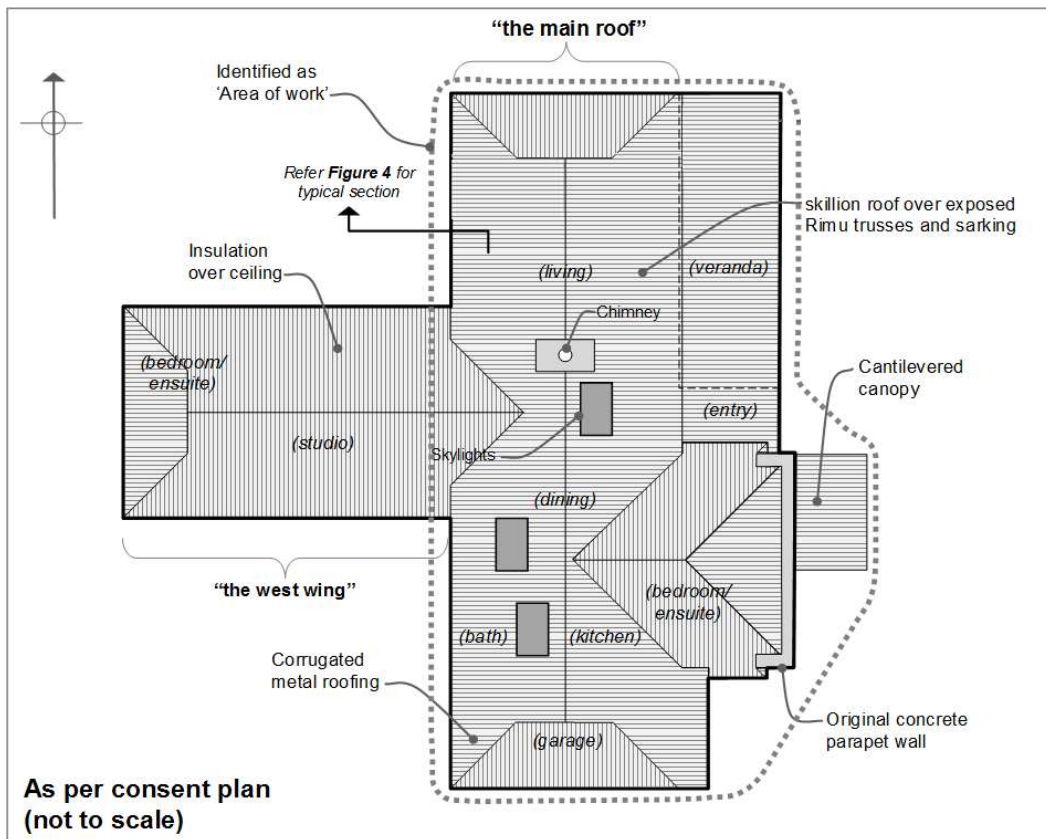
Figure 3: Approximate roof plan

2.3.1 The extent of building work considered in this determination is shown in Figure 3. The original 200 mm thick concrete walls and roof framing have been retained, with a new insulated roof constructed as shown in Figures 4 and 5.

- The 2011 skillion roof design included plywood sheet sarking to support the roof underlay with a 25mm gap above the rigid insulation board. The insulation board was cut to fit between purlins and sat directly on top of the original permeable ceiling linings – as shown in Figures 3 and 4.
