Determination 2023/031

Decision by an authority to grant a building consent and issue a code compliance certificate for a small dwelling

251 Priest Road, Eketāhuna

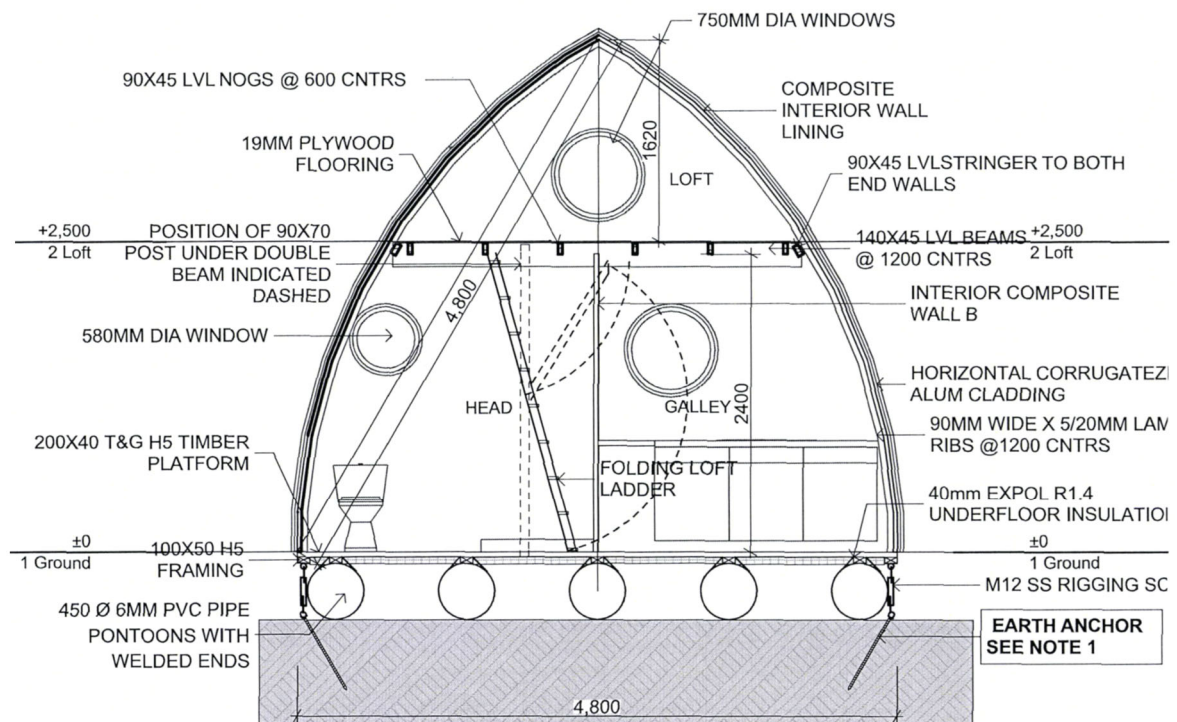
Figure 1: Section showing construction of dwelling (not to scale).

5.2.1. The underfloor insulation was on the approved plans (see Figure 1) but was not installed by the manufacturers. During the consenting process, the authority accepted the manufacturers' explanation that the dwelling did not need to comply with clause H1 because it was off the grid. The insulation was installed as part of the remediation work.

Ministry’s assessment	<ul style="list-style-type: none"> • Section A shows 22mm stainless steel rigging screws installed vertically along the side/external wall, connecting the timber platform to the load-point (head) of the screwed earth anchor, which is inclined at 40-45degrees (see Figure 1). • The installation guide for the specified proprietary anchor required the anchors to be installed at the same angle (or close to) as the load for maximum pull out strength³³ when guying on an angle. • As-built, the earth anchors are guyed at an angle, meaning the rigging screws are not vertical as per the design. Also, the anchors
