Determination 2023/042

The compliance of a wall made of ponga logs with clauses B1 and B2 of the Building Code

1/12 Rokino Road, Taupō

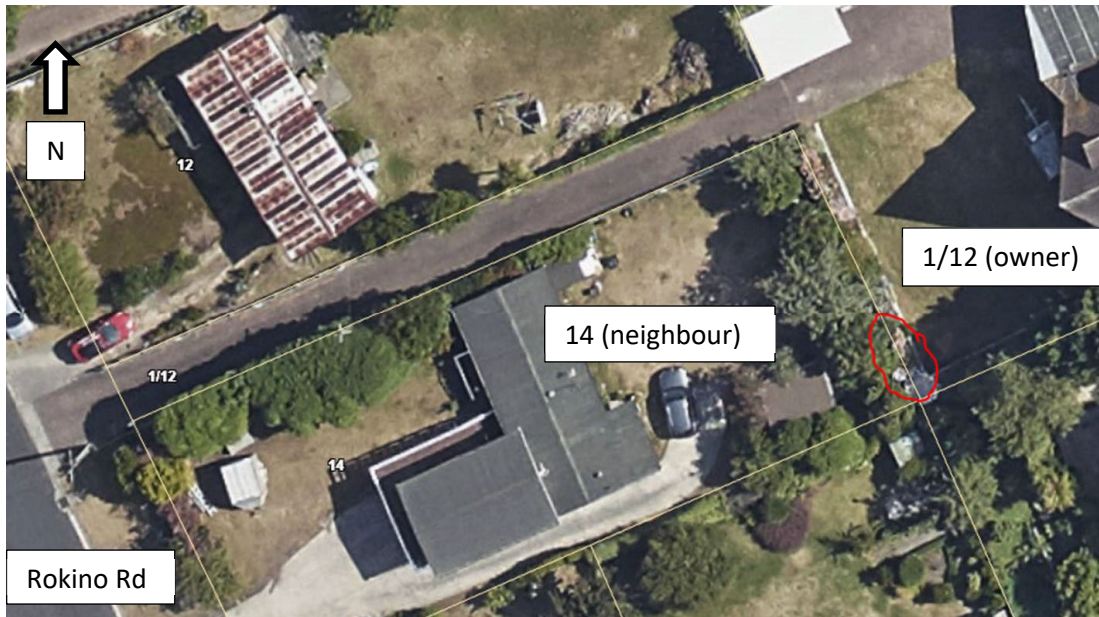
Figure 1: Aerial photograph provided by the authority, showing the approximate location of the new section of punga wall, circled in red

- 2.3.4. a 5.6m long by 2m high section of new wall constructed of ponga logs, which is the section of wall that is the subject of this determination (see Figure 1).
