Determination 2012/012

The issue of a notice to fix for a 6-year-old garage addition to a house at 28 Hackett Street, Auckland

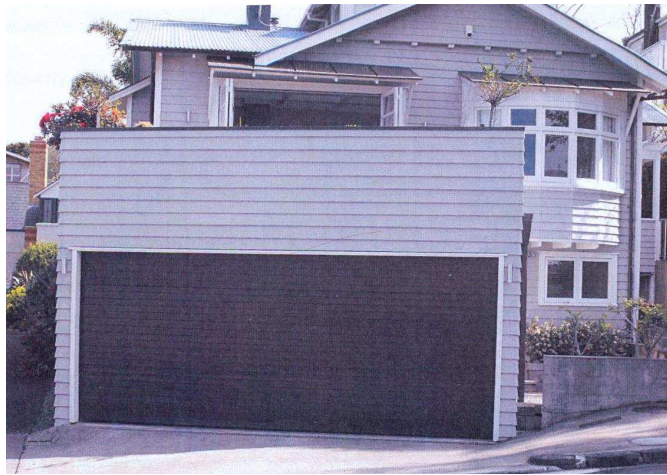
2.4.1 The building work considered in this determination is limited to the garage addition shown in Figure 1. The garage is at the northeast boundary of the site, and provides a roof deck accessible via new bi-fold doors from the adjacent living room. Construction is generally conventional timber frame, with a concrete slab and foundations and some specifically engineered steel portals and beams.
