November 2013

Guidance for building in toe slump areas of mass movement in the Port Hills (Class II and Class III)

Supplementary guidance to ‘Guidance on repairing and rebuilding houses affected by the Canterbury earthquakes’, December 2012.

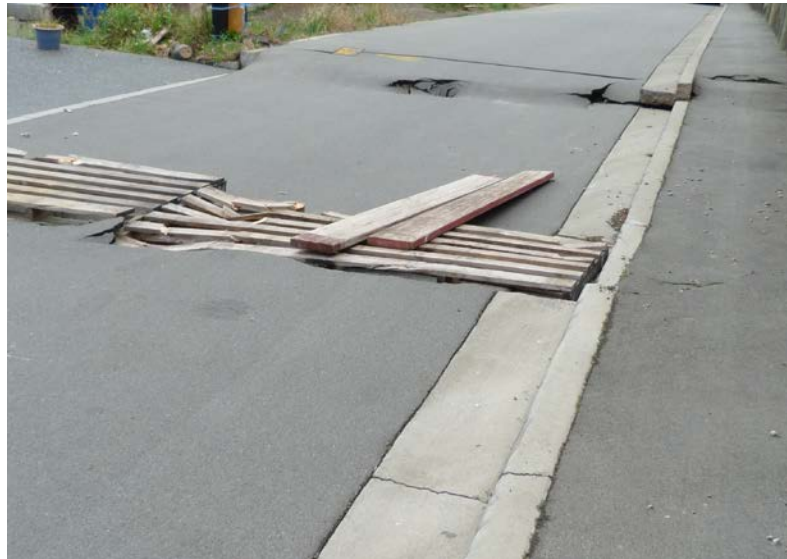
Figure 3: Graben formed in extension area of a mass movement feature
(A graben is a depressed block of land bordered by parallel defects)

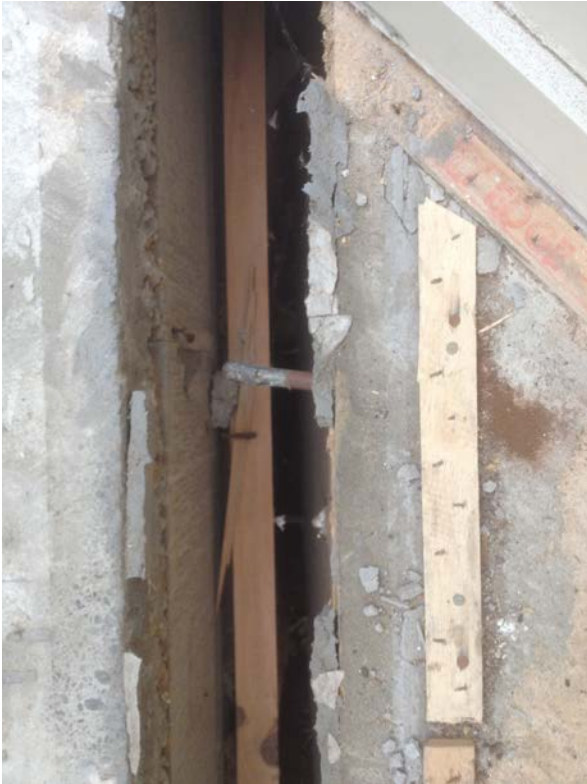
Figure 5: Rupture at interface between single and two storey parts of house

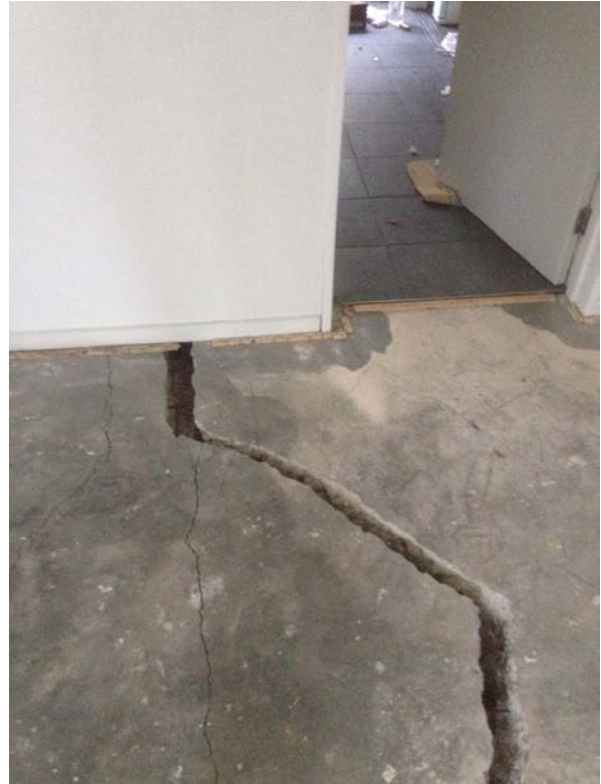
Figure 6: Rupture of concrete floor slab

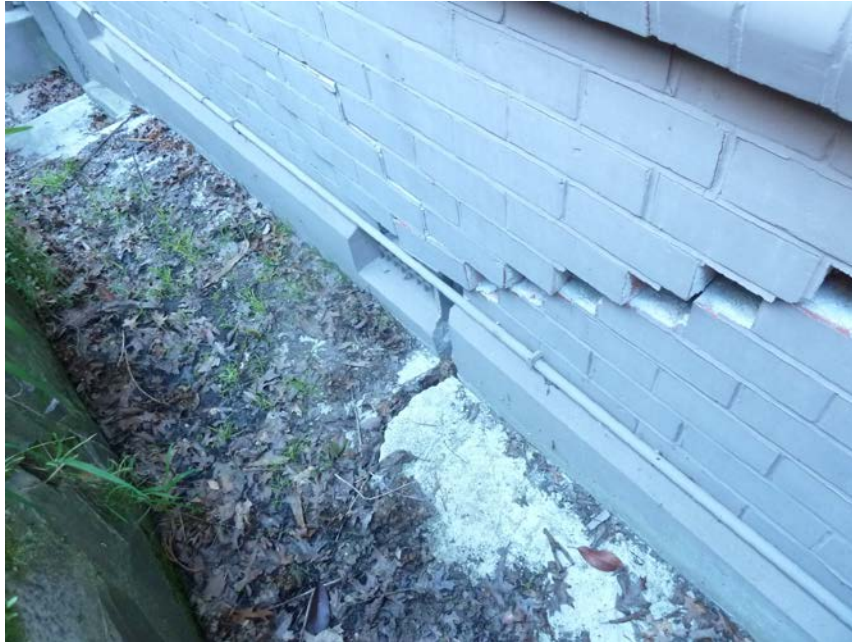
Figure 7: Rupture of concrete foundation beam and brittle cladding
