Determination 2018/004

The refusal to issue a code compliance certificate for an 11-year-old house with monolithic cladding at 21 Athenree Road, Athenree, Bay of Plenty

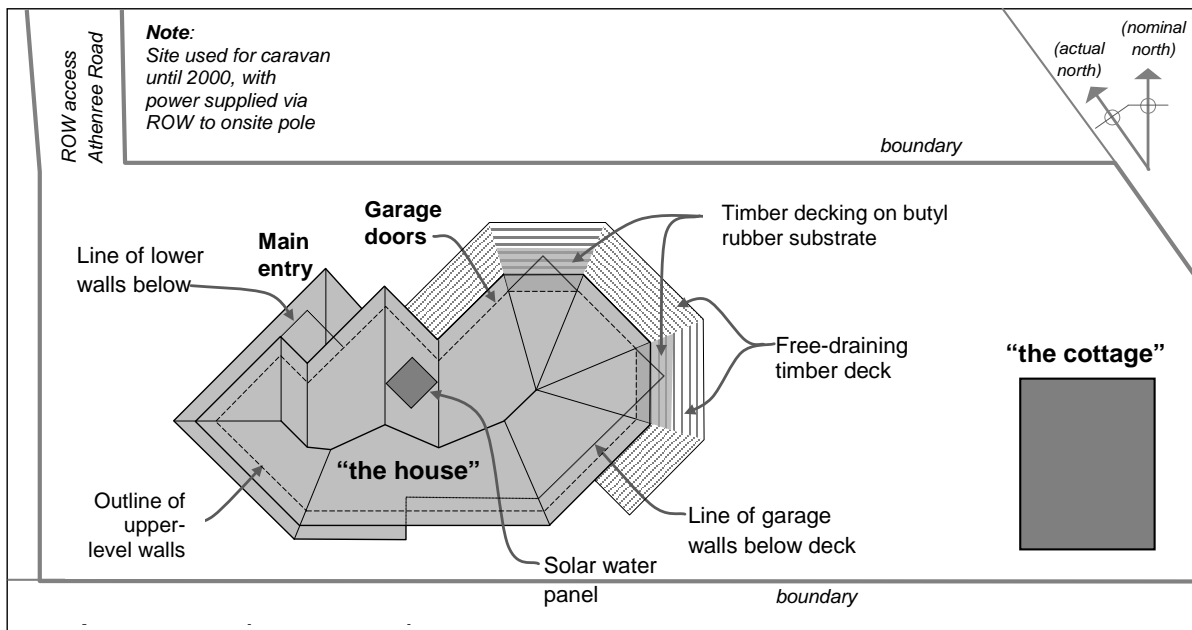
Figure 1: Site plan (not to scale)

- 2.2.1 The building work that is the subject of this determination consists of a detached two-storeys-high house on a gently sloping site in a high wind zone for the purposes of NZS 3604⁴. The expert has taken the main entry and garage door as facing northwest (NW) and this determination follows that convention as shown in Figure 1. The house is assessed as having a moderate weathertightness risk (see paragraph 7.2).
