Example of a Potential Impact Classification assessment report – Zeta Dam

Assessment under the Building (Dam Safety)
Regulations 2022

SEPTEMBER 2024

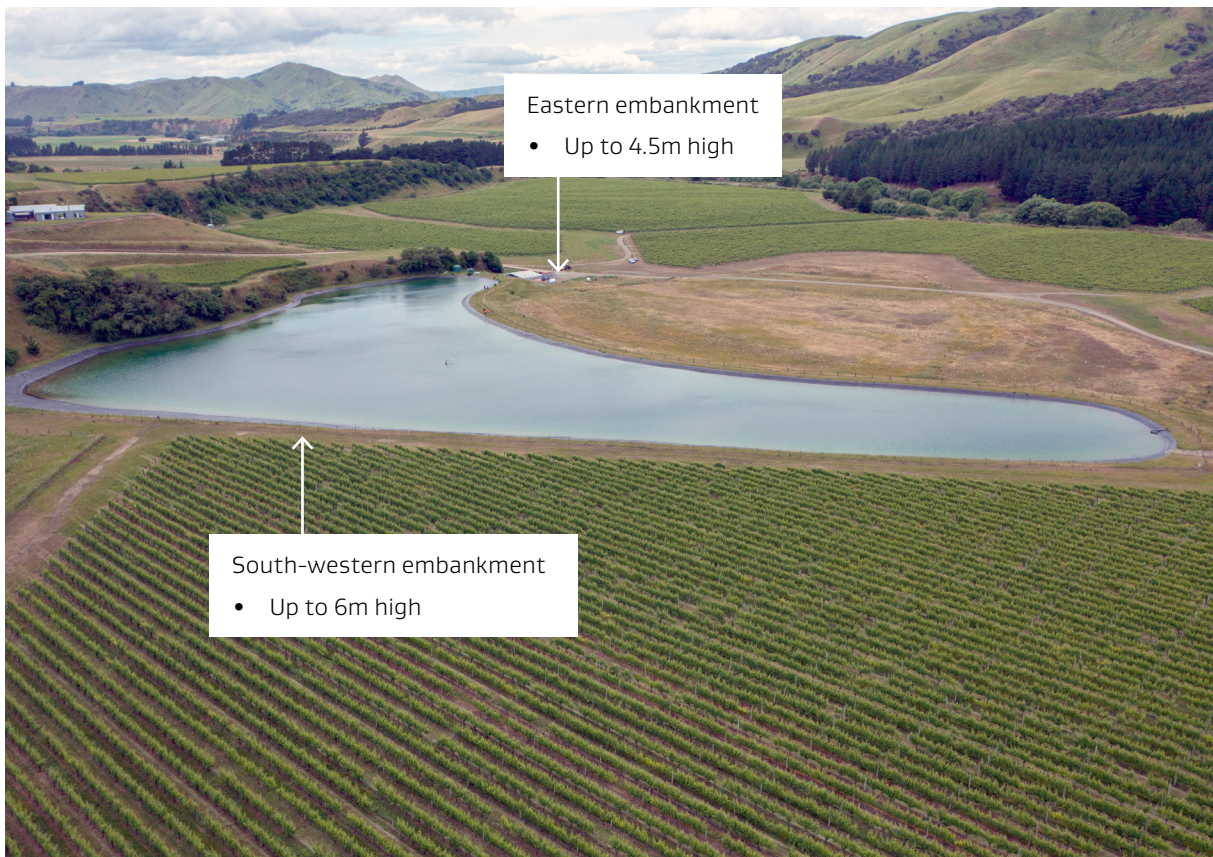
Figure 1: Zeta Vineyard Dam

The area in which the reservoir is located is designated as a 'Rural Zone' within Heathcote Regional Council's Resource Management Plan. The predominant use of the site and neighbouring properties is viticulture and low- density farming operations. The location of the reservoir in relation to the features listed above is indicated on Figure 1.

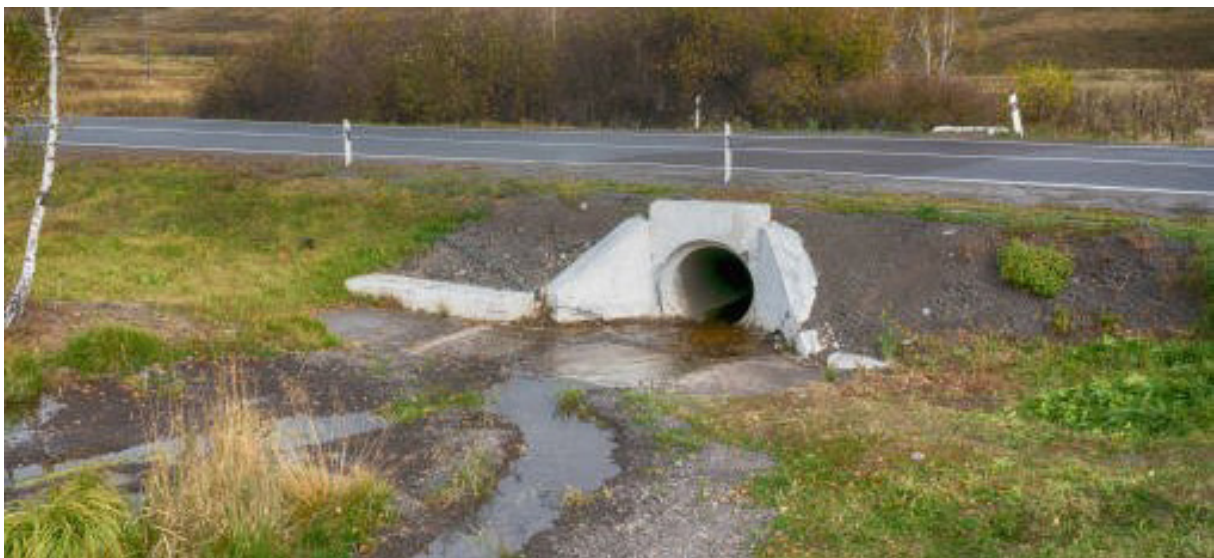
A breach of the dam is likely to release flows that will rapidly exceed the capacity of the culvert and overtop the road (refer Figure 3). The gradient of the stream at this location is approximately 1-in-100, however, it is still possible that the flow would wash out or damage the road.

Figure 3: Hillcrest Road at Tau Creek culvert. (Source: Heathcote Regional Council)

Hillcrest Road is a local east-west road and is situated approximately 1000m south of Zeta Vineyard Dam. The most likely scenario of floodwaters reaching the road is via the floodplain of Tau Creek (approximately 2km downstream of Zeta Vineyard Dam). Under normal conditions, flows in Tau Creek pass within a culvert under the road.
