Determination 2006/41

Refusal of a code compliance certificate for a building with a “monolithic” cladding system at 134J Rangatira Road, Birkenhead, North Shore City

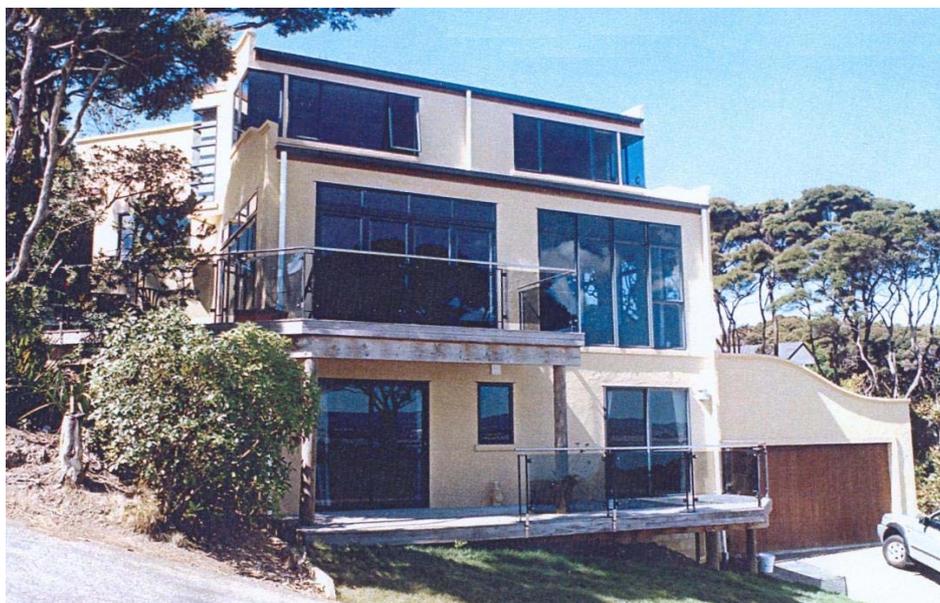
- 2.1.1 The building work consists of a detached house situated on a steeply sloping excavated site, which is in a very high wind zone in terms of NZS 3604². The split-level house is a maximum of three storeys high. The external walls are conventional timber framing built on either concrete floor slabs or timber framed floors. Where the ground floor is timber framed, this is supported on pole foundations. The house shape is of a relatively complex form with pitched roofs at several levels that generally have perimeter parapet walls and wall-to-roof junctions. There are only minimal eaves projections. The external walls are clad with a painted textured-finish fibre-cement cladding and plastered polystyrene trims are planted onto the cladding at the horizontal floor joints and the window sills. The parapets also have projecting and shaped polystyrene cappings.

- 2.1.2 A triangular bay window is cantilevered out at the upper floor bedroom 1 and this has a flat roof constructed over it. A small cantilevered flat roof is constructed over the main entrance. Two small separate timber-framed decks are situated at the ground and first floor levels and a large timber-framed deck is constructed around three elevations at the first floor level. The decks are supported by timber posts and beams and have glazed balustrades.
