Determination 2007/23

Refusal of a code compliance certificate for a garage at 3 Oswald Crescent, Newlands, Wellington

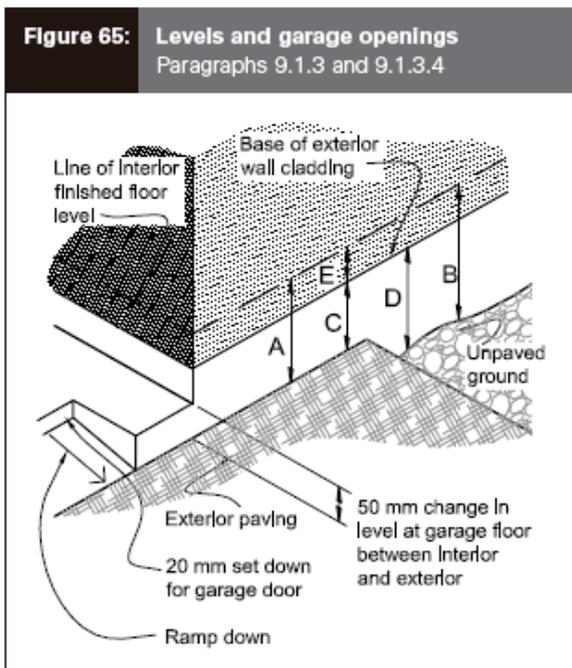
Refer to Figure 65 and Table 18 for overall level change requirements.

For the reasons set out in 6.1.5 and 6.1.6 below, I take paragraph 9.1.3.4 to refer to lined garages but not to unlined garages. For timber weatherboard cladding, Figure 65 and Table 18 require ground clearances of 100mm to paved surfaces.
