Determination 2007/71

A dispute in relation to the issue of a notice to fix for retaining walls at Nos 36, 36A, 38, and 38A Normans Hill Road, Onehunga, Auckland

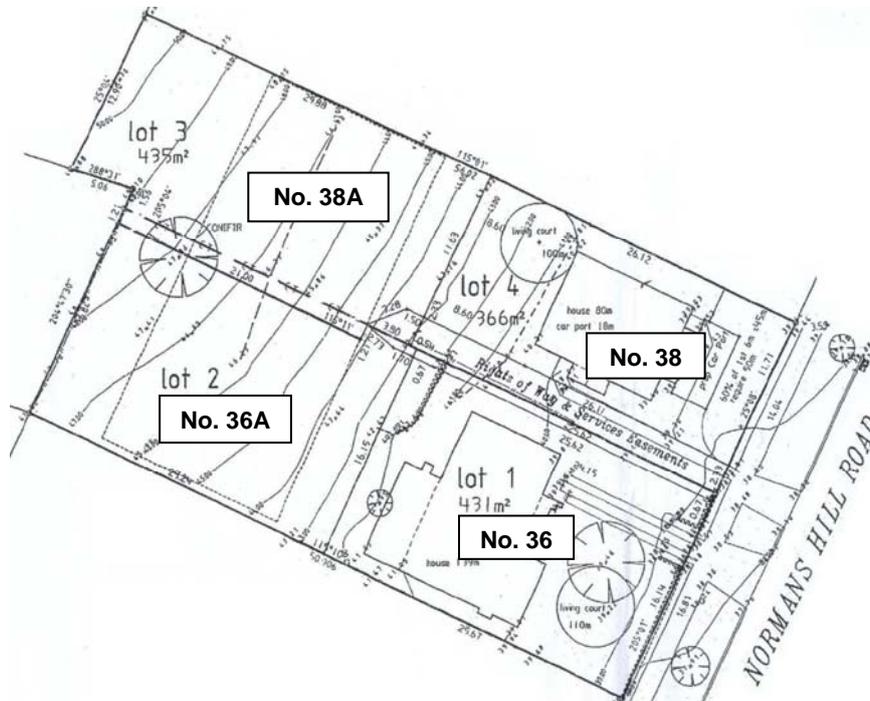
Figure 1: Site layout taken from the unit title plan

- 2.1 The building work consists of retaining walls constructed on 4 separate properties. There are two parallel retaining walls, supporting a concrete driveway slab, that run along the entire end boundaries of Nos 36 and 38 and for a short distance along the end boundaries of Nos 36A and 38A. The driveway slab gradient rises from the road and its height above the natural ground level along the retaining walls varies from zero at each end to a maximum of approximately 1500mm at the centre. The supporting retaining walls are constructed with circular timber poles concreted into drilled holes and which support timber walings installed above the ground level. No safety barriers are installed along either of these walls.

- 2.2 The retaining walls between adjoining properties 36 and 36A and 38 and 38A are constructed with square timber poles, which support timber walings installed above the ground level. The heights of the retaining walls do not exceed 1 metre above the lower ground level. Fences have been installed above these walls.
