Determination 2008/11

Refusal to issue a code compliance certificate for additions to a house at 38 Kauri Point Road, Laingholm, West Auckland

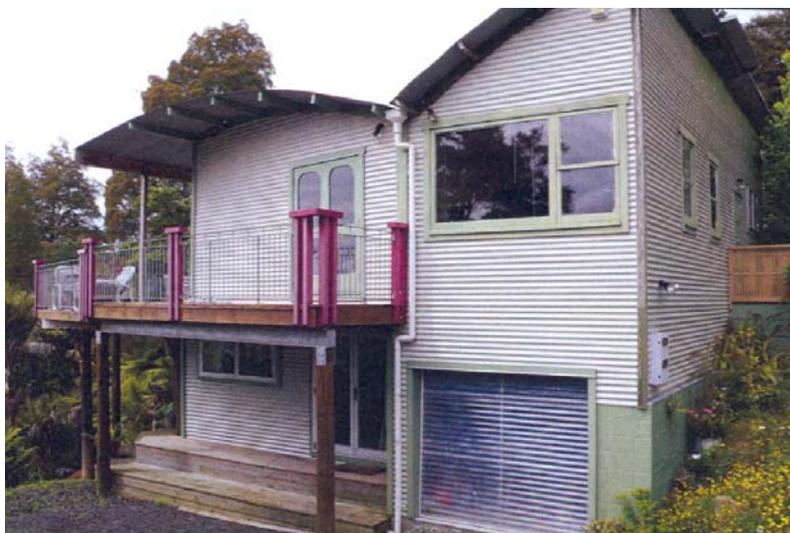
- 2.1 The altered house is two-storeys high and is situated on a sloping site, which is in a high wind zone for the purposes of NZS 3604³. The house is relatively simple in shape and form but with complex roof features and is of timber framed construction built on timber-framed floors. The house generally has timber pole foundations and the ground floor garage has a concrete slab. The main corrugated steel covered roof is partially convex and has main internal gutters and a plastic gutter at the east elevation. The roof has eaves and verge projections that vary from 600mm to 1000mm wide.

- 2.3 Based on the tested samples of the external wall framing timber, I am of the opinion that it is likely to be boron treated.
- 2.4 The external wall cladding is corrugated “colorsteel” fixed horizontally and directly to the framing over building paper.
