Determination 2008/99

Determination regarding the refusal to issue a code compliance certificate for a 6-year-old semi-detached townhouse at 20 Paremata Drive, Paremata

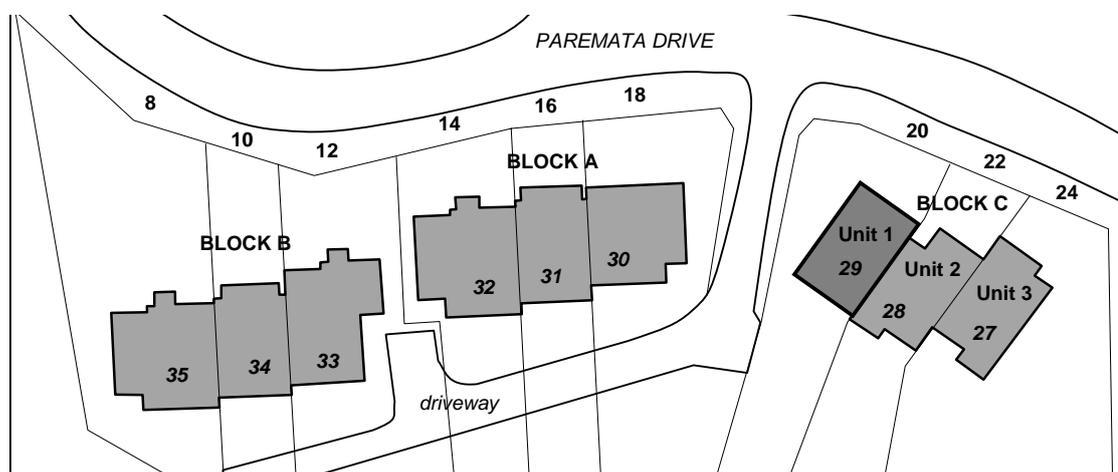
- 2.3 The following site plan shows the development:

Street No.	Building title <i>(as used in this determination)</i>	Amended consent number	Original unit No. in consent drawings	Dwelling title <i>(as used in this determination)</i>
8	Block B <i>(The second block – completed 2001)</i>	2000 0986	35	
10			34	
12			33	
14	Block A <i>(The first block – completed 2000)</i>	2000 0985	32	
16			31	
18			30	
20	Block C <i>(The third block – completed 2002)</i>	2000 0987	29	Unit 1
22			28	Unit 2
24			27	Unit 3

- 2.4 The townhouses are generally of similar construction and materials, and each block of townhouses was progressively constructed, sold and occupied, between 2000 and 2002.
