Determination 2009/86

Determination regarding the refusal to issue a code compliance certificate for house alterations and a new garage at 3 Le Roy Road, Waiheke Island

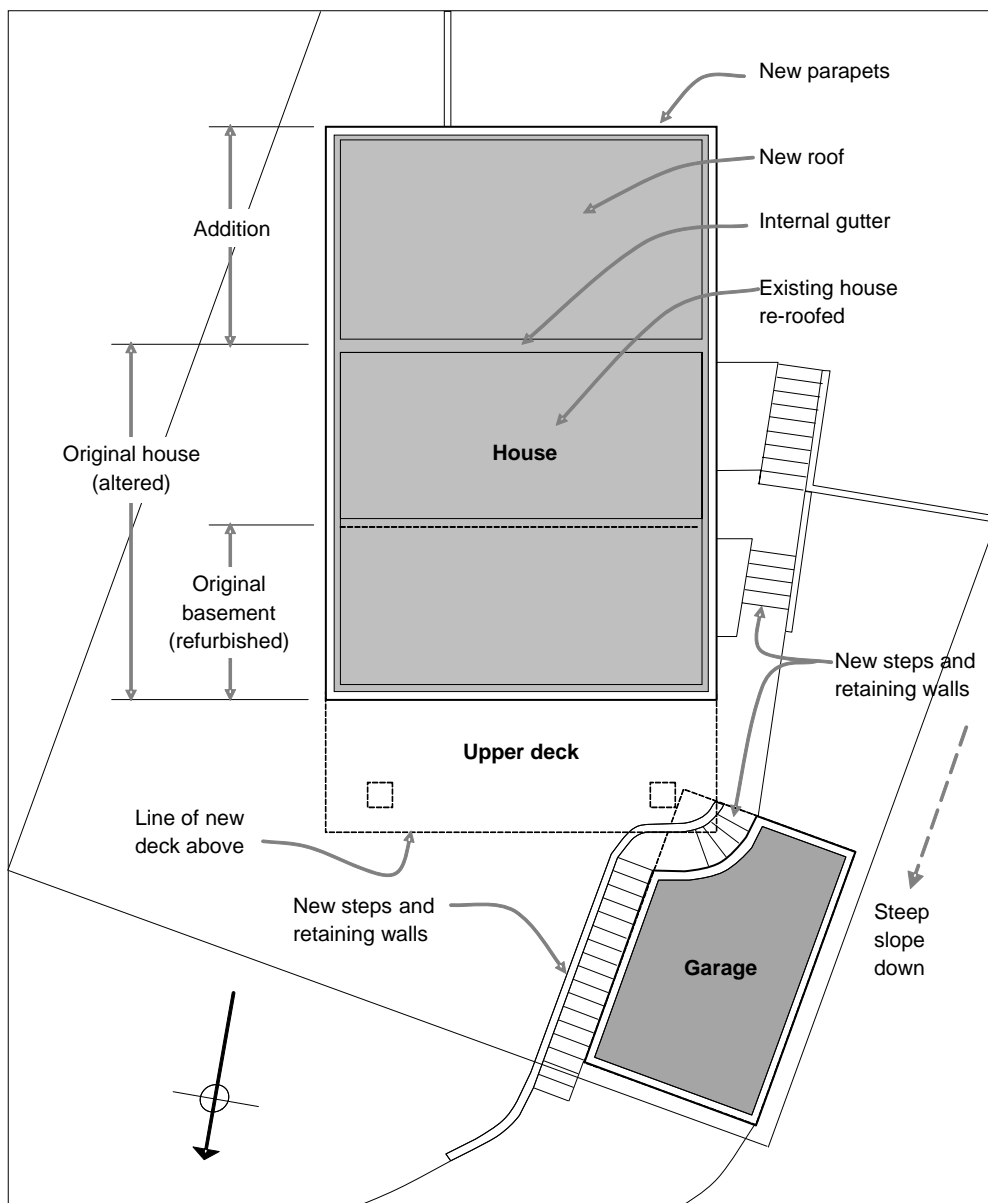
2.3.1 The building work considered in this determination is shown in the following sketch:

- new aluminium windows and doors
 - interior alterations and refurbishment.
- 2.6.2 The altered house has the appearance of a new building, with a simple rectangular form that is two storeys to the north and single-storey to the south. Construction is generally conventional timber framing with some specifically engineered steel beams, concrete slab and foundations to the north and south (with a timber framed subfloor area between), and concrete block retaining walls to the southeast corner.
