Determination 2009/41

The issue of Notices to Rectify in respect of three 9-year-old detached houses at 22A, 22B and 22C Clarke Road, Onehunga, Auckland

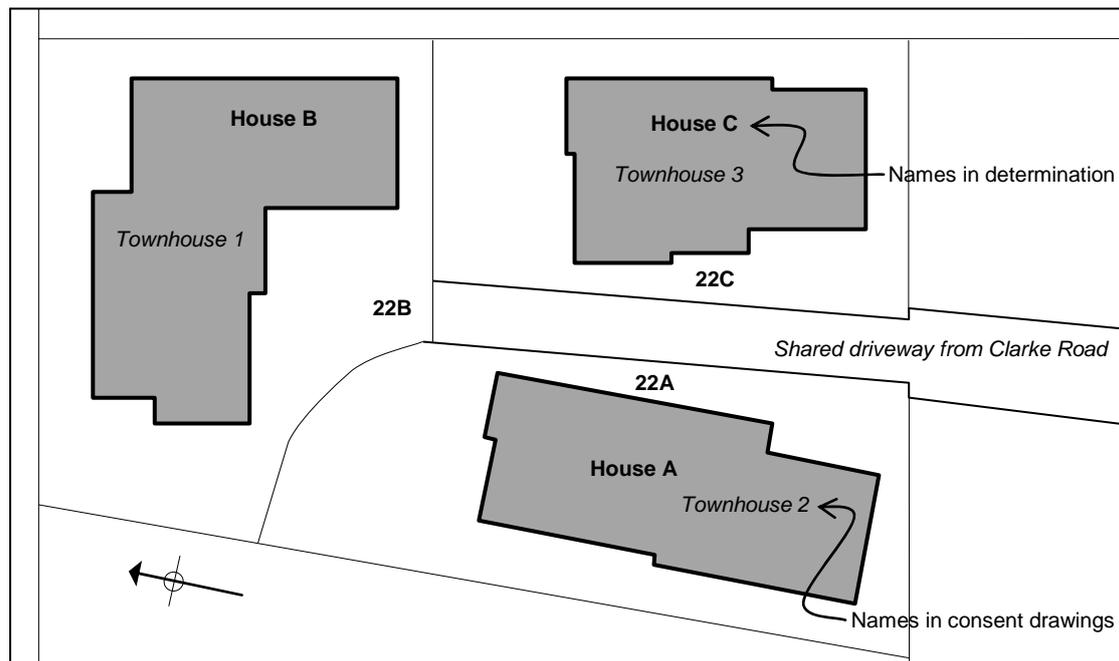
Figure 1: Site plan

- 2.2 One building consent was issued to cover the construction of a group of three houses, as shown in figure 1 (page 3).
- 2.3 Each individual house has its own separate land and building title, which clearly defines legal boundaries to each property. Property titles for the subdivision were deposited when the houses were almost complete in July 2000. The houses have different designs, but are generally of similar construction and materials.
- 2.4 The houses are situated on a gently sloping site in a low wind zone in terms of NZS 3604³. Construction is conventional light timber frame, with concrete slabs and foundations, concrete masonry foundation walls, 30° pitch pressed metal tile roof
