Determination 2009/50

The code compliance of a cement bonded particle board clad and steel framed house at 37/5 Driftwood Place, Mangawhai

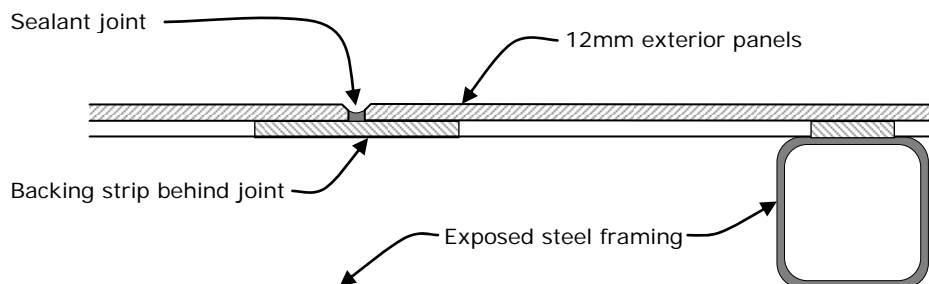
2.6.3 The garage walls are unlined and have no infill framing. 12mm CBPB panels are fixed directly to the steel framing, with CBPB glued to form vertical backing strips behind the joints as shown in the following sketch:

5.4.3 The expert noted that the consent drawings did not specify the use of building wrap. Given the nature of construction and the cavities, the expert was ‘not sure what benefit (if any) building wrap would add to this particular situation’. (However, I note that a building wrap would have separated the steel framing from the CFPB in the case of the garage construction shown in paragraph 2.6.3).
