## Determination 2009/56

### Determination regarding the refusal to amend a consent and issue a code compliance certificate for a 5-year-old block of 5 semi-detached townhouses at 131 to 139 Metcalfe Road, Waitakere City

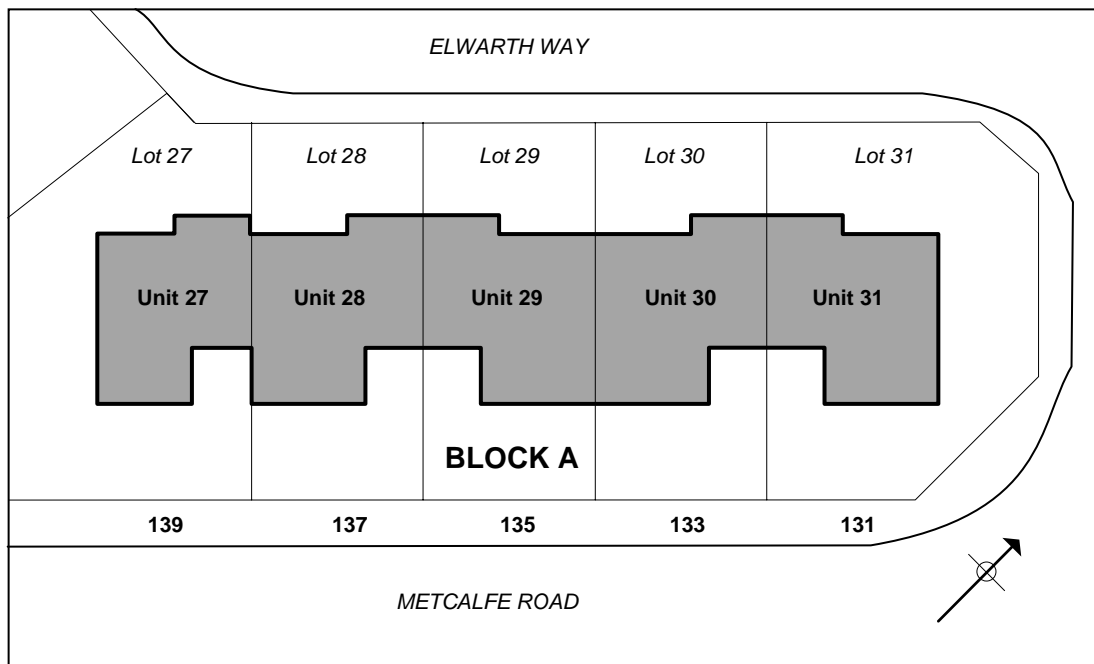
3.1 The following site plan shows Block A:

3.2 Block A is a two-storey building, which is situated on a flat site in a low wind zone in terms of NZS 3604<sup>3</sup>. The block sits parallel to Metcalfe Road, with the main
