Determination 2010/003

Refusal to issue a building consent for cladding remediation work to a house and garage building at 7 Kane Street, Opuia

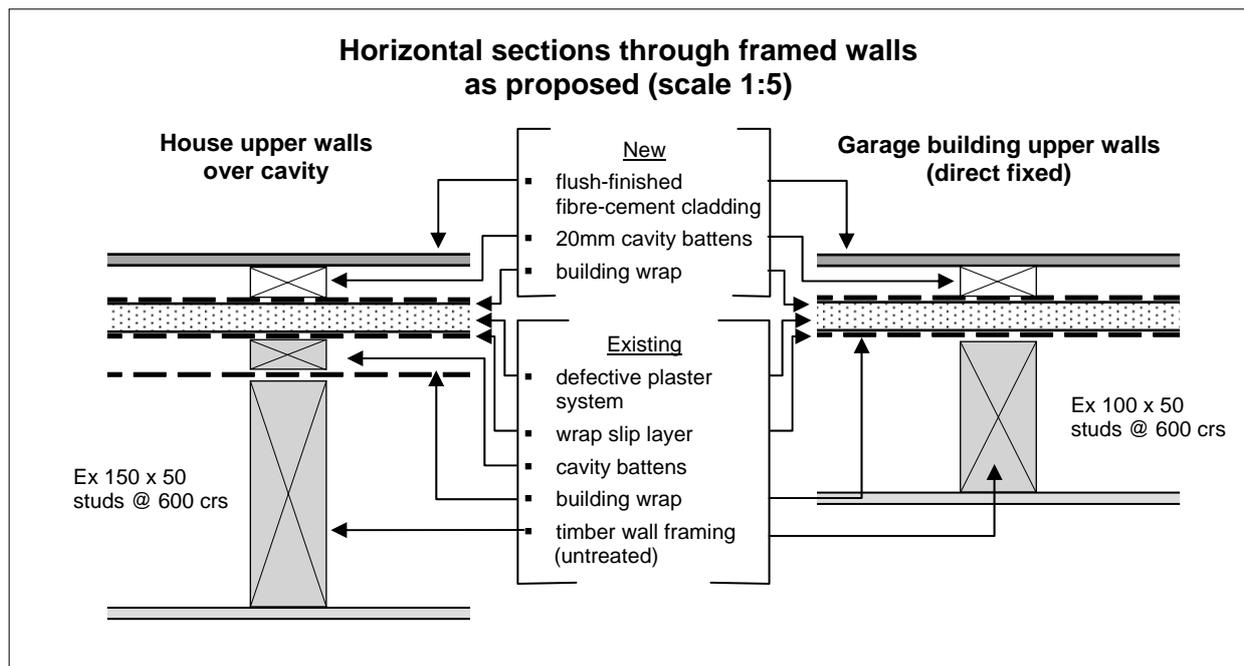
- 2.7.1 The proposed re-cladding includes the retention of the existing plaster cladding, over which a new cladding system is installed. The proposed monolithic cladding is a variation of a proprietary ventilated cavity system, with 7.5mm thick fibre-cement sheets fixed through 20mm timber battens and finished with flush-finish jointing filler over mesh-reinforced joints and an applied textured plaster system.
- 2.7.2 In the details, the 20mm timber battens are shown fixed directly through the existing solid plaster, with the new battens forming a cavity between the cladding sheets and the existing plaster as indicated in the following sketches:

- 2.7.3 New colour-coated steel flashings, specified to be ‘texture coated’, are shown extending from the existing flashings to overlap the new cladding. The existing parapet flashings are to be retained, with a note stating ‘existing cap flashing to be dismantled and adjusted to fully enclose cavity based cladding’.
- 2.7.4 New apron flashings are shown at the junctions of the walls with the decks and canopies. Although not detailed, the proposed scope of works also includes the installation of new ridge flashings to the current single lengths of the roofs.
- 2.7.5 The specification calls for the plaster to the curved ensuite roof to be covered with a ‘composite fibreglass’ membrane, which is to be taken over the junction with the walls and up behind the new cladding. New butyl rubber membrane is to be installed to the roof gutters and the entry canopy.
