Determination 2010/023

The refusal to issue a code compliance certificate for a 6-year-old building at 514 Cashel Street, Linwood, Christchurch

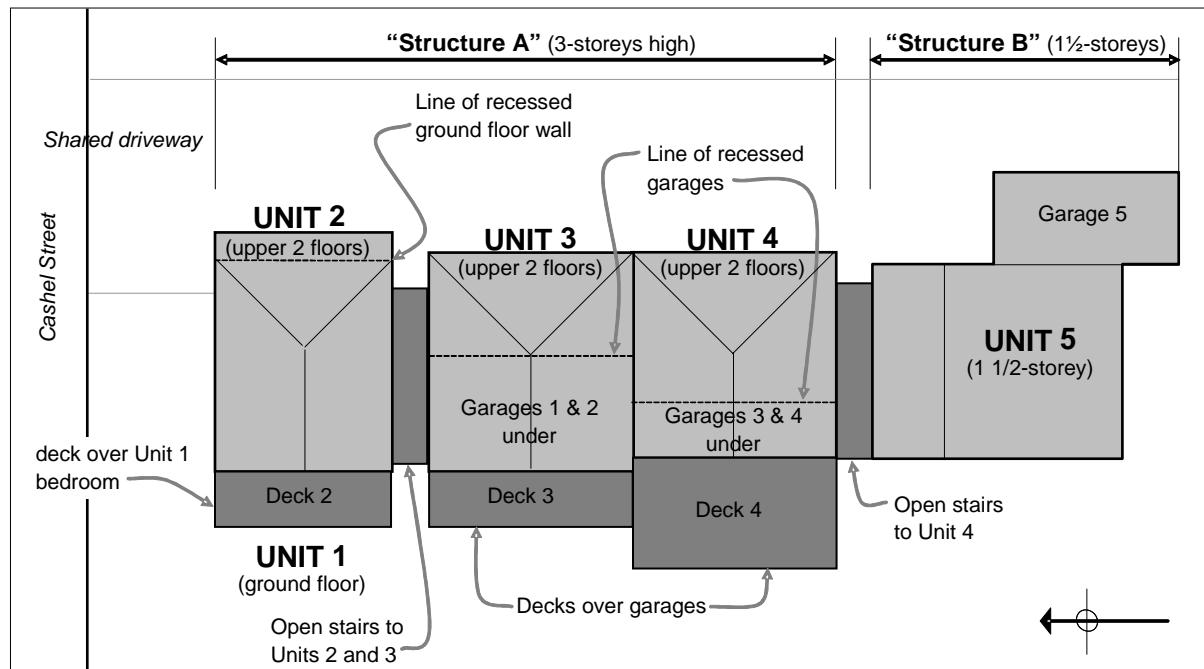
of two distinct structures (“Structure A” and “Structure B”), which are linked by an open staircase with canopy above.

2.2 The site plan generally appears to be as shown in the following sketch:
