Determination 2010/058

Refusal to issue a code compliance certificate for additions and alterations to a house at 26 Resolution Rise, Cooks Beach

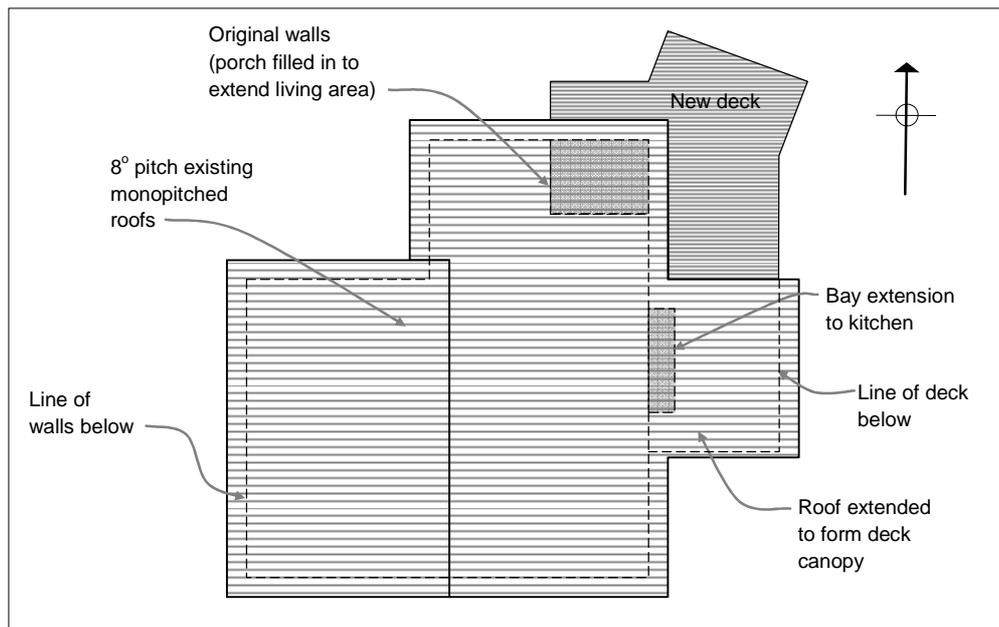
Figure 1: The house and alterations

2.2.1 The alterations (shown in Figure 1) includes the following:

- the original porch enclosed to extend the dining area (“the dining extension”)
- a deck constructed around the north east corner and along the east elevation
- the roof extended as a canopy above part of the new deck (“the deck canopy”)
- a 600mm deep bay under the deck canopy to extend the kitchen
- interior alterations, including:
 - removing the original master bedroom and extending the living area
 - extending the opening between the altered living and dining areas
 - new kitchen and bathroom fittings and various partition changes.

- 2.2.2 Construction of the alterations is conventional timber frame with some specifically designed elements. A steel 'portal brace frame' braces the new deck canopy and a glue laminated beam spans the extending opening between the altered living and dining areas. The design engineer has provided a producer statement for the design of 'beams and bracing portal'.
