Determination 2010/081

Refusal to issue a code compliance certificate for a 7-year-old house with a solid wall system at 1/28 Ireland Road, Panmure, Auckland

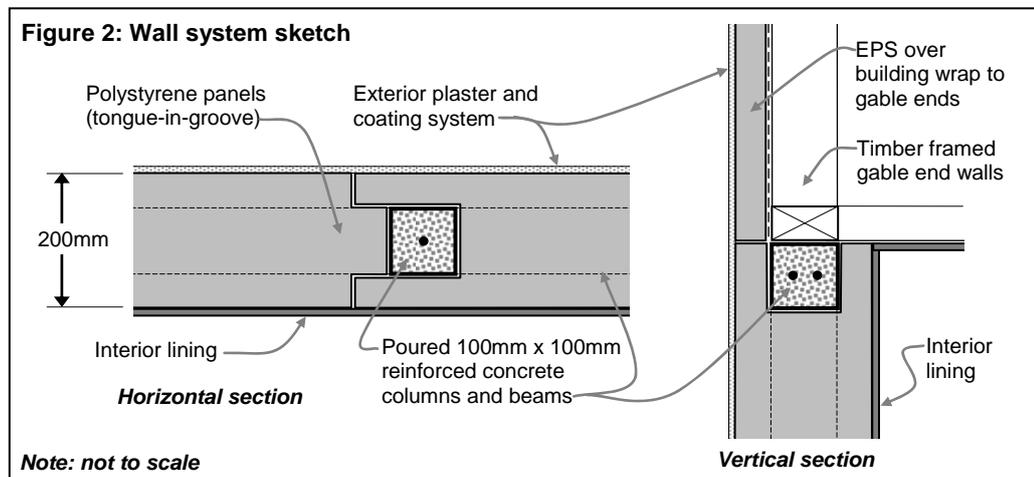
3.3.1 The exterior walls are a proprietary solid wall system, as shown in Figure 2.

3.3.2 The main walls of the house are constructed from 200mm thick interlocking polystyrene (“EPS”) panels, which provide formwork for a reinforced concrete post and beam structure. Steel reinforcing rods connect the poured columns and beams to the foundations, the first floor framing and the roof framing. At joinery openings, timber sub-frames fit within the panel grooves, with planted solid timber packers against which the windows and door are face-fixed.

3.3.4 At the base of the solid walls, a plastered polystyrene band with a sloped top is installed over the junction with the foundation wall. A similar band covers the inter-storey junction. A 3mm mesh-reinforced plaster system is applied as a continuous coating to the exterior of the solid walls, the polystyrene bands, the EIFS backing sheets and the fibre-cement backing sheets.
