Determination 2010/122

Determination regarding a notice to fix for remedial work and alterations to a house at 17 Doncaster Terrace, Porirua

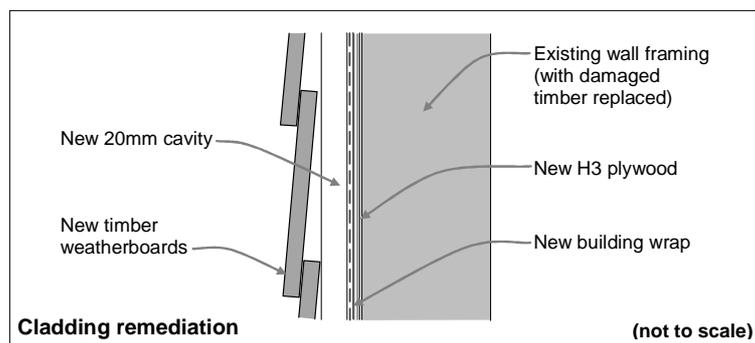
- 2.4.1 The general construction of the re-clad exterior walls is shown in the following simplified sketch:

- 2.4.2 A sheathing of 7mm H3-treated plywood bracing covered with a layer of building wrap is fixed to the outside face of the original repaired wall framing. Bevel-backed timber weatherboards are fixed through timber battens, the building wrap and the plywood to the framing, with the battens forming a 20mm cavity between the cladding and the wrap. Timber facings and scribes are used at corners and around re-used windows and doors. The entry canopy columns have been re-clad in weatherboards.
