Determination 2011/051

Regarding the refusal to issue a code compliance certificate for one of a complex of six 16-year-old townhouses at 8 Moturoa Street, Thorndon, Wellington

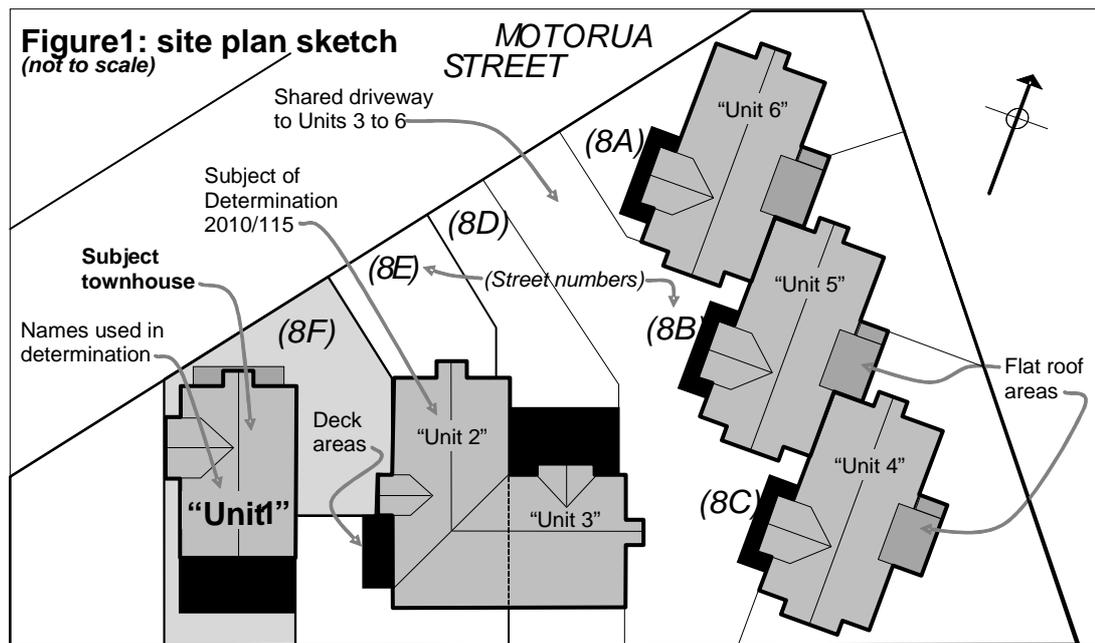
- 2.1 The site is in a very high wind zone in terms of NZS 3604⁴ and gently slopes to the west, apart from a steep bank at the western end of the south boundary. The site has been subdivided to provide six properties with separate titles.
- 2.2 The three-storey-high units were constructed under one building consent and are similar in materials and design, with some variety in planning. As shown in the site plan sketch in Figure 1, the development consists of a detached unit at the west, three semi-detached units to the east and a two-unit building in-between:
