Determination 2011/080

The exercise of powers in respect of a notice to fix issued for a house at 859 Whangaparaoa Road, Whangaparaoa, Auckland

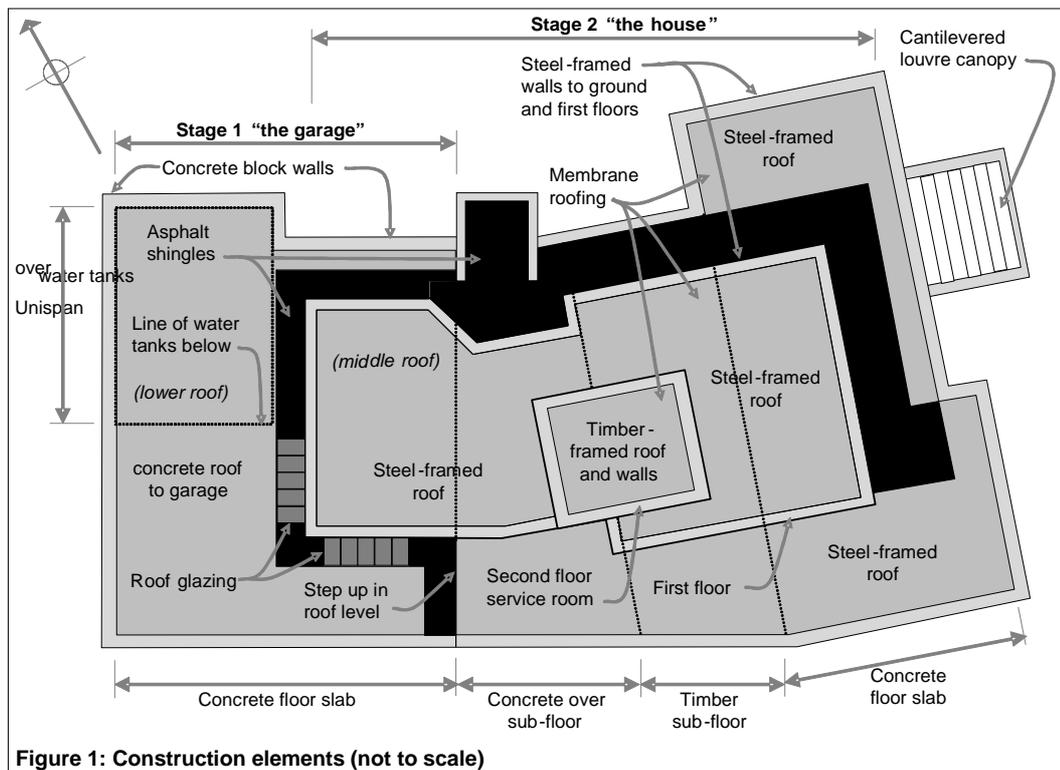
2.8 A paved deck on the lower house roof extends along the east and most of the north wall of the first floor. A stainless steel tube and wire balustrade is side-mounted to a membrane-covered upstand, with an internal gutter adjacent to the upstand.

2.9 A small free-draining timber deck is fixed to the foundations of the east wall of the living room. Above the deck, steel beams form a cantilevered canopy, with the fascia band extended around the outside and louvres installed within the frame.
