## Determination 2011/113

# Whether building consents for proposed new houses on land subject to subsidence and slippage at Ohinau Drive, Opito Bay should be subject to section 73(1) notifications

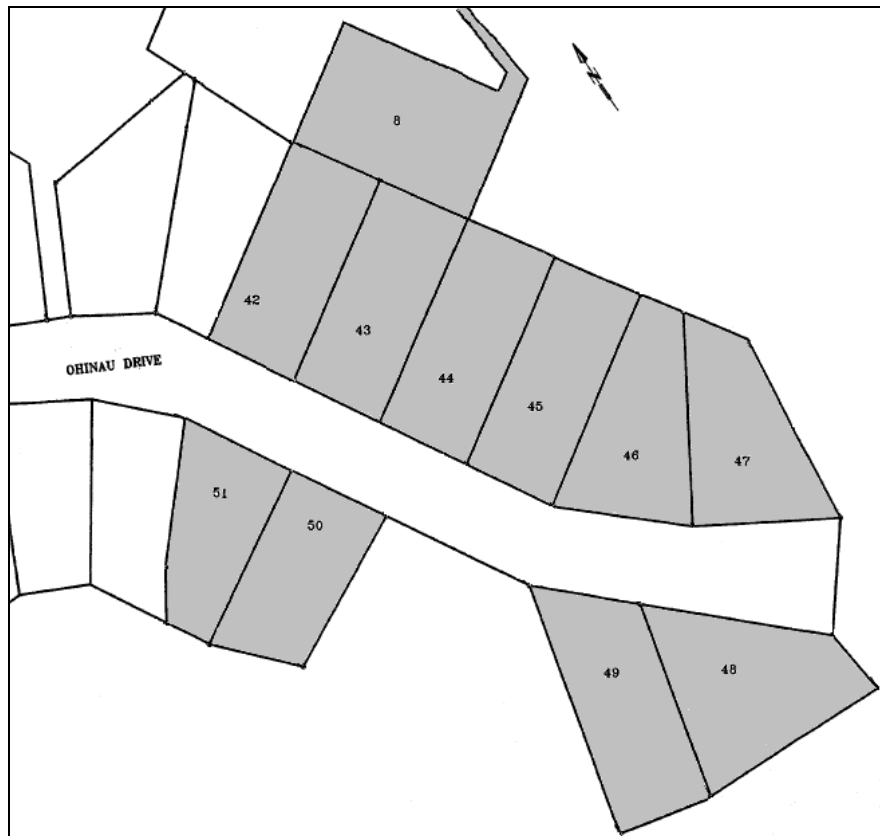
- 2.3 The following figure shows the subdivision and location of the 11 lots that are subject to this determination (Lots 42 to 51 and Lot 8) shown here shaded.
