Determination 2013/012

Regarding the refusal to issue a code compliance certificate for a 10-year-old commercial fitout to a building carried out under the supervision of a building certifier at 173 Victoria Street, Wellington

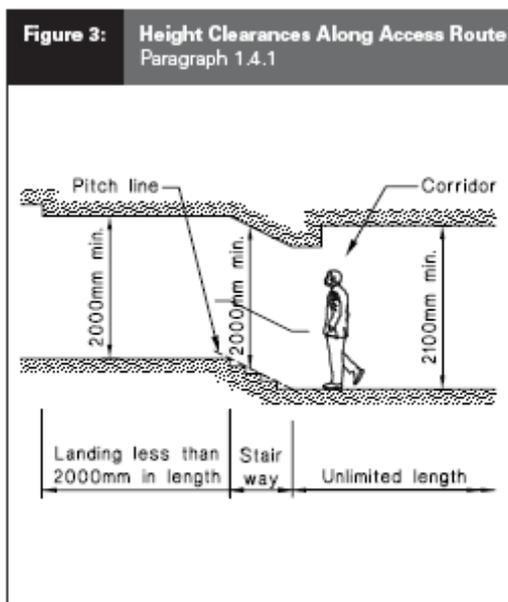
- 1.4.1 Access routes shall have height clearances complying with Table 1 and as shown in Figure 3.

Prone access spaces (e.g. sub-floor access, limited length)	450 mm
Crawl spaces for servicing (30 m max length)	800 mm
Pedestrian access routes (unlimited length)	2100 mm
Landings, stairways and corridors (less than 2 m in length)	2000 mm
