Determination 2013/049

Regarding the refusal to issue a code compliance certificate for 7-year-old building work at 550 Whitecliffs Road, Coalgate

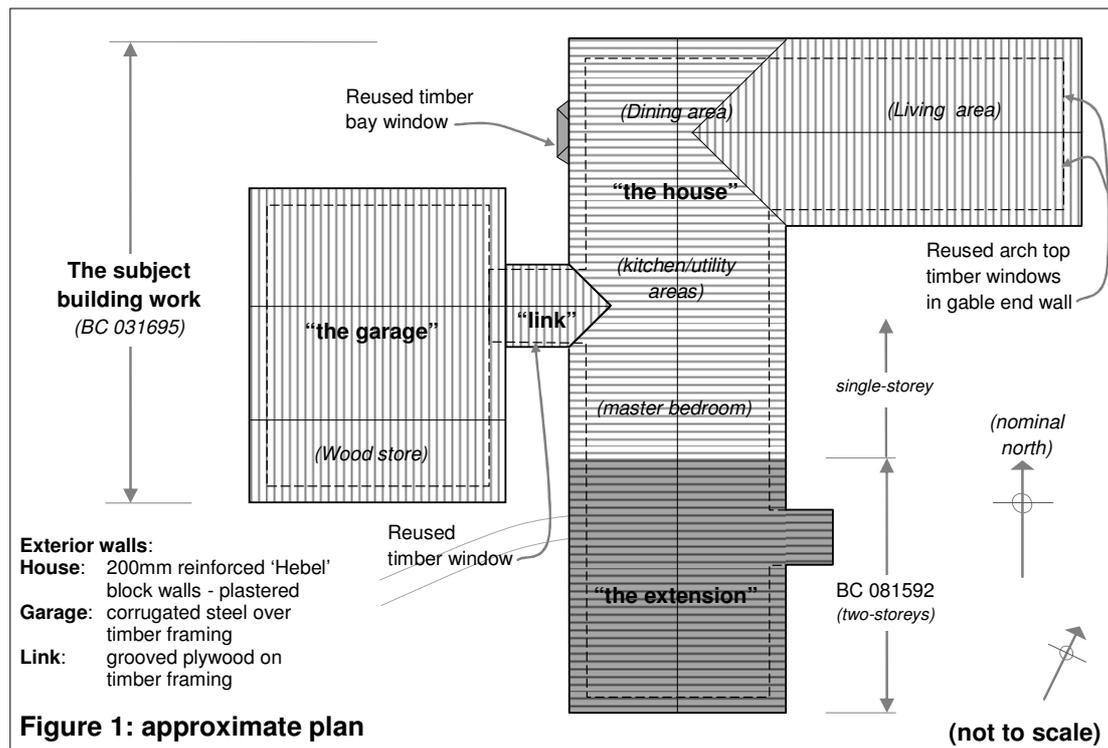
- 2.1 The completed house is situated on a large steeply sloping rural site in a zone requiring specific design with respect to wind and snow loading. The building platform is to the north of the isolated site, with a long driveway providing access from the road. The house is fairly simple in plan and form, and is assessed as having a low weathertightness risk.
- 2.2 The completed house is shown in Figure 1 and comprises:
- The first consent (BC 031695), the subject building work, consisting of an L-shaped house section (“the house”) connected to a separate garage/storage building (“the garage”) via a glazed passage (“the link”).
 - The second consent (BC 081592), which is a two-storey extension to the south, providing two additional bedrooms and a games room (not considered in this determination).

2.3 Construction is a mix of conventional light timber frame and reinforced lightweight masonry, with concrete foundations and floor slabs, plastered masonry and corrugated metal wall claddings, plywood cladding to the link and profiled metal roofing and timber windows. The 30° pitch gable roofs have eaves and verges of more than 600mm overall, with a 15° pitch lean-to roof above the garage wood store.
