Determination 2014/019

Regarding the decision to issue a code compliance certificate in respect of the decks to Units 220, 221, and 237, at Terrace Downs Villas, Lake Coleridge Road, Darfield

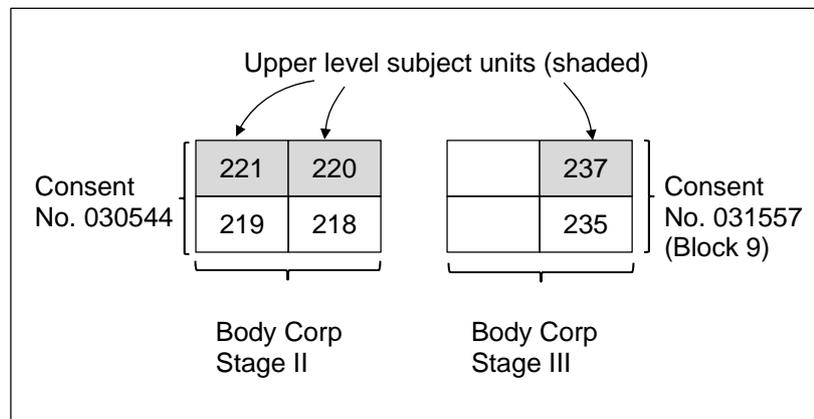
Figure 1: Schematic elevation of the units within the subject blocks

1.3 In regard to the units that are the subject of this determination: Units 220 and 221 are part of work constructed under Consent No. 030544 with the owners represented by Body Corporate Stage II. Unit 237 is part of work constructed under Consent No. 031557 with the owners represented by Body Corporate Stage III (refer Figure 1).

- 2.3.1 Units 220 and 237 are on the upper level of separate but adjacent blocks; the decks to these units are, in part, located over bedrooms in the units underneath. Units 218, 219, 220 and 221 are in the same building; Unit 219 is located under Unit 221, Unit 218 is located under Unit 220. Unit 235 is located under 237 in Block 9, (refer Figure 1).
- 2.3.2 The decks were originally consented to have a liquid applied membrane over a concrete substrate with a tiled finish. The surface of the deck to unit 237 has the original construction. The surface of the decks to Unit 220 and 221 were replaced and now consist of a seamless waterproofing membrane.
