Determination 2015/019

Regarding the refusal to issue a code compliance certificate for a 13-year-old house with masonry veneer at 1178D Cove Road, Langs Beach, Waipu

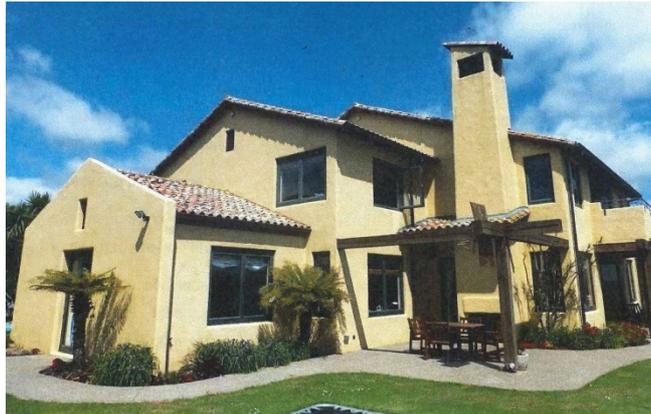
2.2 Construction is generally conventional light timber frame, with some specifically engineered elements. The house has concrete foundations and floor slab, plastered masonry veneer wall cladding, clay tile roofing and aluminium joinery.
