Determination 2015/054

Regarding the refusal to issue a code compliance certificate for a 21-year-old house at 44B Upper Wainui Road, Raglan

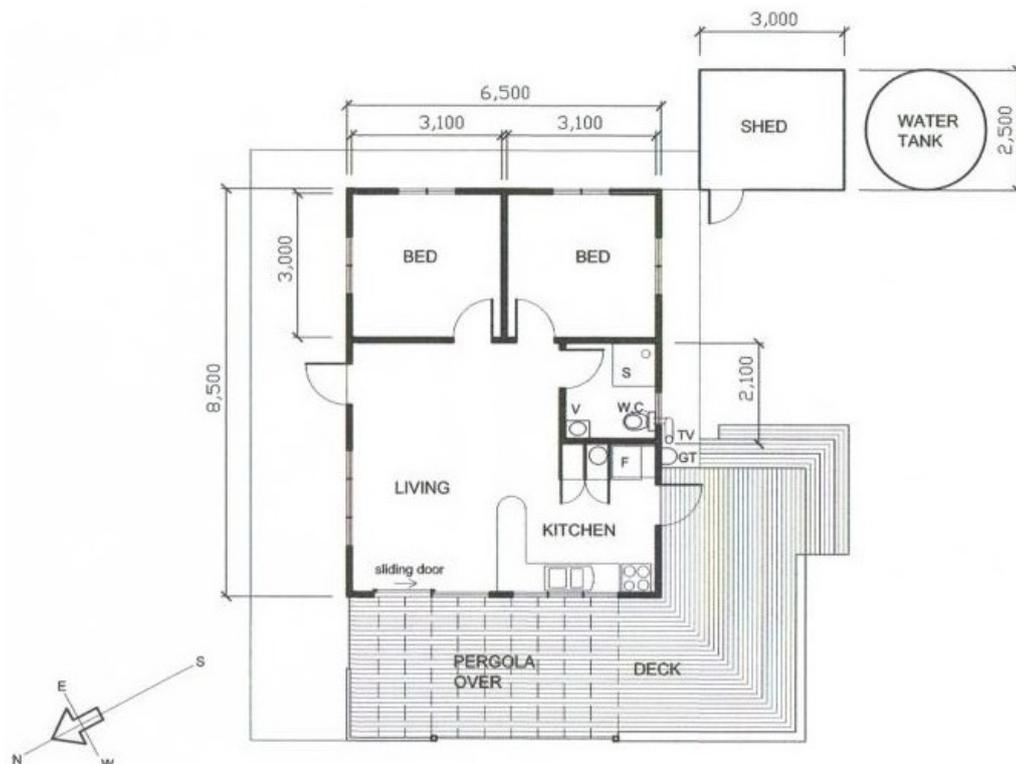
Figure 1: Floor plan (not to scale)

- 2.1 The building is a 55m² two-bedroom house located on a sheltered rural site approximately 1km from the coast at Raglan.
- 2.2 It is constructed on a concrete floor with timber framed walls and timber roof trusses. The wall cladding is a fibre-cement weatherboard with metal soakers at the four corners. Over the trusses and building paper is fixed long-run, ribbed, powder-coated metal roofing.
- 2.3 A proprietary synthetic rubber flashing has been used around the only roof penetration for the terminal vent. The 15° pitched roof is a simple gable with a 600mm overhang to each of the long sides of the house, and an approximately 300mm overhang to each of the gable end walls. Exterior doors and windows are coated aluminum.
