Determination 2017/066

Regarding the refusal to issue a code compliance certificate for a 19-year-old house with mixed claddings at 16 San Lorenzo Rise, Henderson Heights, Auckland

This determination is concerned with the compliance of a 19-year-old house. The determination considers the authority's reasons for refusing to issue the code compliance certificate and whether the building work complies with the requirements of the Building Code.

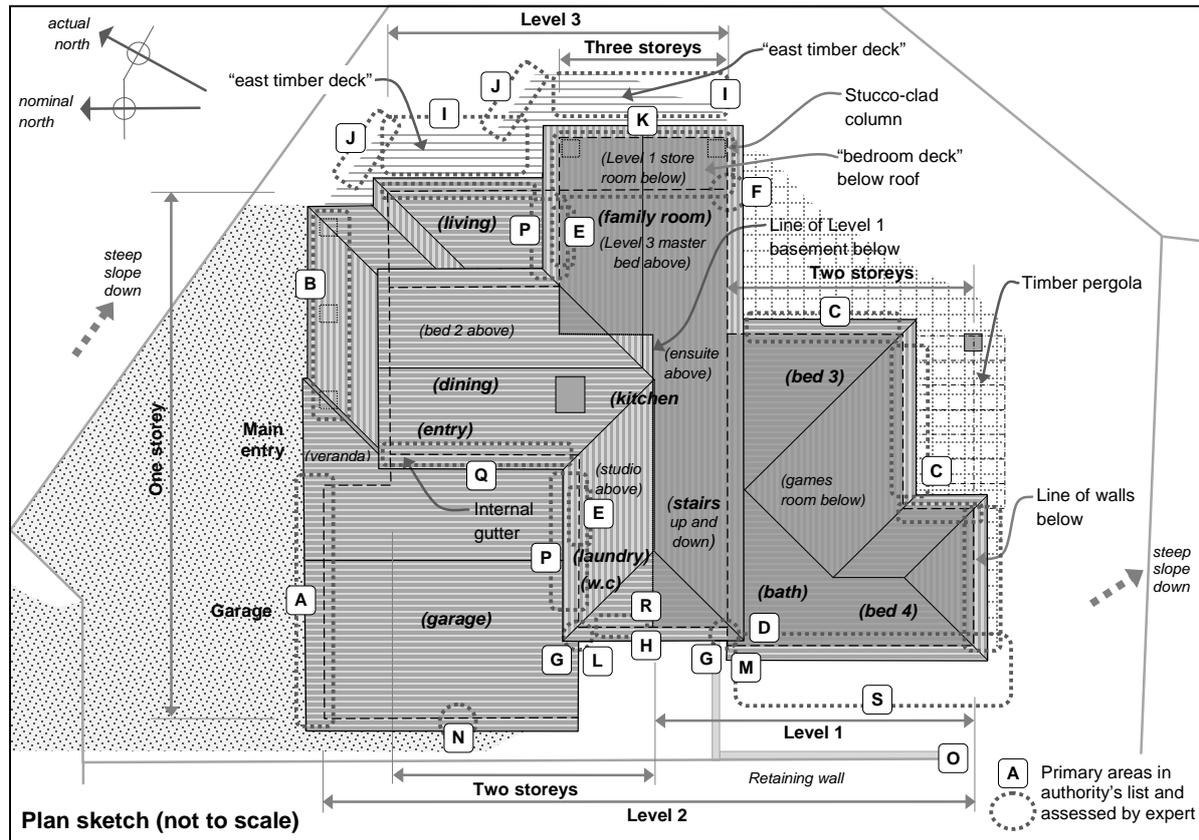
Figure 1: Approximate site plan

2.2 As shown in Figure 1, the house includes three levels as follows:

3.2.2 The authority listed items that required attention (“the authority’s list”), which were ‘not limited to’ the following (in summary, with relevant locations in brackets – see Figure 1):

1. Cladding:
 - a) Clearances to brick veneer (Area A,B,C, D)
 - b) Clearances to apron flashings and membrane (Area Q)
 - c) Cracks to stucco
 - d) Damaged cladding at end of west stucco/brick flashing stop end (Area H)

- h) Cladding/joinery junctions (Area E,H,R,)
 - i) Unknown flashings to deck/upstand and roof/wall junctions (Area F)
2. Cracks to interior plasterboard

- d) Deteriorating deck joists to timber deck (Area I)
 - e) Deteriorating mechanical deck fixings (Area I)
 - f) Timber deck joist spacing not in accord with drawings (Area I)

- g) Deteriorating timber balustrade (Area J)
4. Drainage:
 - a) Unable to inspect west elevation due to water ponding (Area D, S)
5. Meter box: panels dislodged (Area N)

6. Compliance of new balustrade to bedroom deck (Area K)
7. Plumbing:
 - a) Broken pipe supports (Area L,M)
 - b) Damaged waste pipe to west gulley trap (Area L)

8. Retaining wall: not shown on approved plans (Area O)
 9. Roof:
 - a) Damaged apron flashings and cracked roof tiles (Area P)
 - b) Membrane to internal gutter (Area Q).
- 3.3 It appears that the applicant carried out some further repairs and maintenance to the house then approached a building surveyor about assessing the items in the authority's list. In an email dated 2 November 2016, the building surveyor described destructive testing that would be involved and recommended that a determination be sought to clarify the areas requiring remediation.
- 3.4 The Ministry received an application for a determination on 2 March 2017, which was accepted on 14 March 2017. The Ministry sought further information from the authority, which was received on 22 March 2017. Consent for the expert to undertake invasive testing was not received until 20 April 2017.
