Determination 2025/004

Compliance of a step on an access route to a toilet facility

22 Setters Line, Milson, Palmerston North

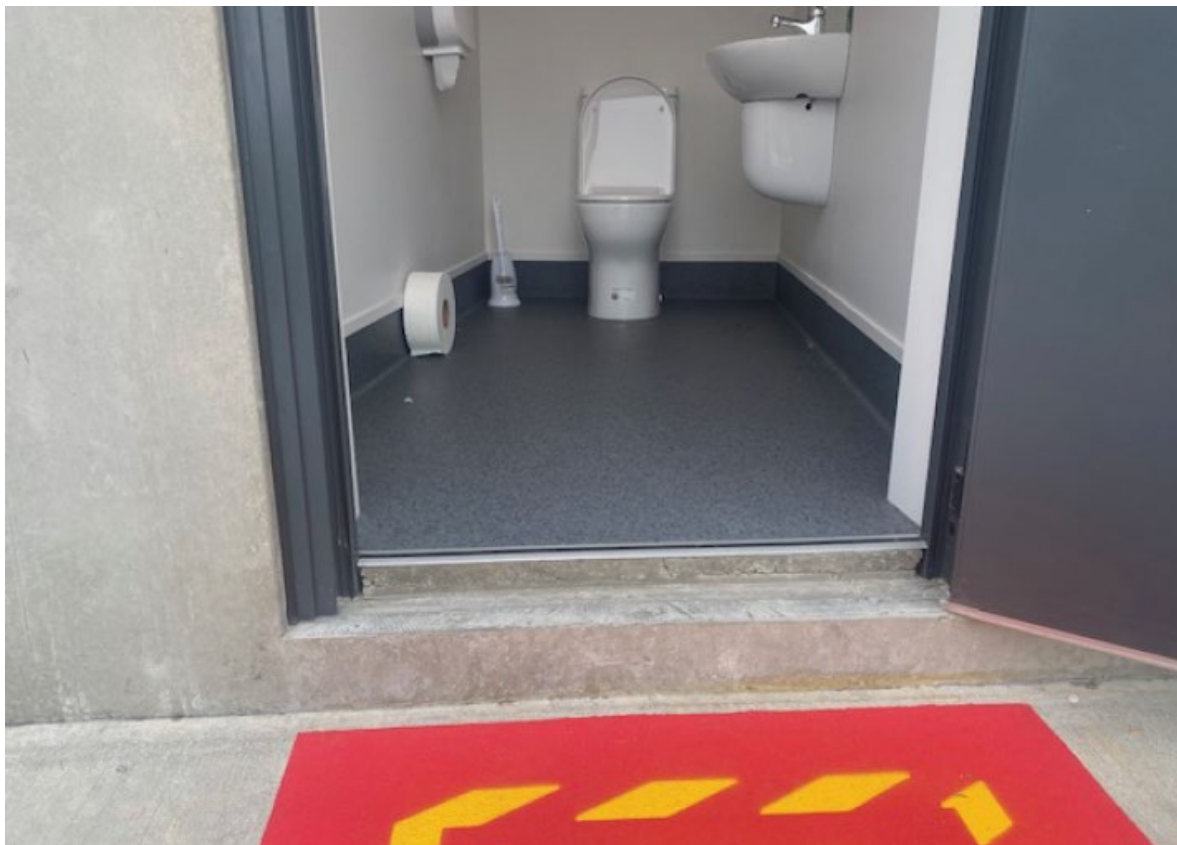
Figure 1: As-built single external step to toilet facility

- 2.6. The only access into the toilet facility is from the external concrete hardstanding via an as-built 170mm-high step⁸, with a door that opens outwards over the step. However, the building consent plans indicate there was only intended to be a vertical difference of 20mm between the internal floor finish of the toilet facility and the external ground level.

⁸ The step incorporates a 105mm vertical rise from the external concrete hardstanding, a 5mm crossfall rebate with the frame of the door fitted at the sides, and a further shallow 60mm vertical rise between the crossfall rebate and the floor of the toilet facility. The step is made from concrete.

- 4.7. Having established the toilet facility is on an access route, I need to consider whether the as-built step complies with clause D1.3.3(i).
- 4.8. The overall difference in levels between the external concrete hardstanding and the finished floor level of the toilet facility is a single step approximately 170mm high.¹¹ This represents an isolated step and does not comply with clause D1.3.3(i).

3. The isolated step at the rear toilet door to be rectified as discussed ... on site.

- 5.1. In accordance with section 188 of the Building Act 2004, I determine the isolated step serving as access to the toilet facility does not comply with clause D1.3.3(i).
